# Play Area / Equipment Operational Inspection

# Llanharry Recreation Ground

LLANHARRY COMMUNITY COUNCIL

04/11/2019, 12:28

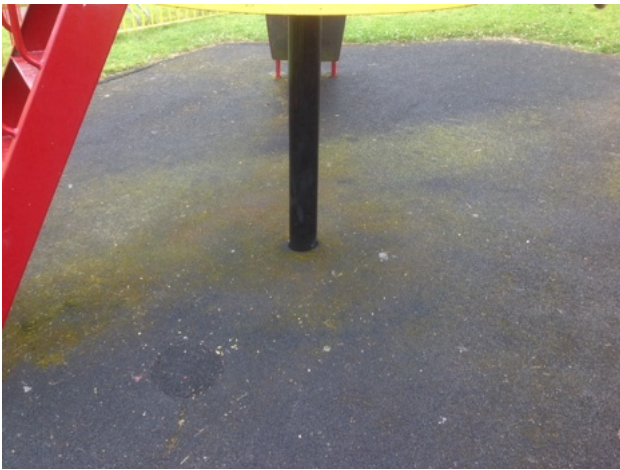
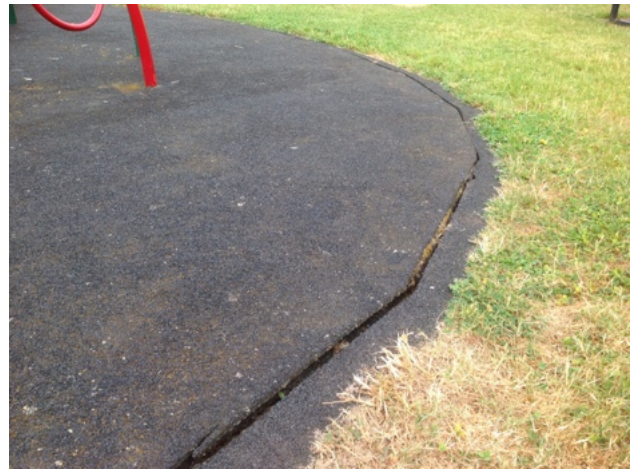
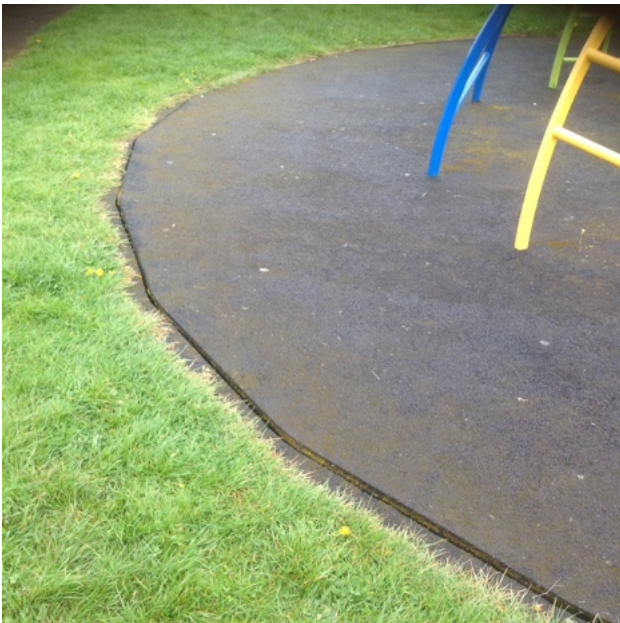
Question	Response	Details
Safety Surfacing	Safe	<p>All items of play equipment are located on wet pour rubber safety surfacing</p> <p>Moss starting to collect on safety surface, monitor</p> <p>The surfacing is shrinking back from the perimeter edging, currently there are no trip points but monitor for any further deterioration</p>
<div style="display: flex; justify-content: space-around; align-items: center;"> <div style="text-align: center;">

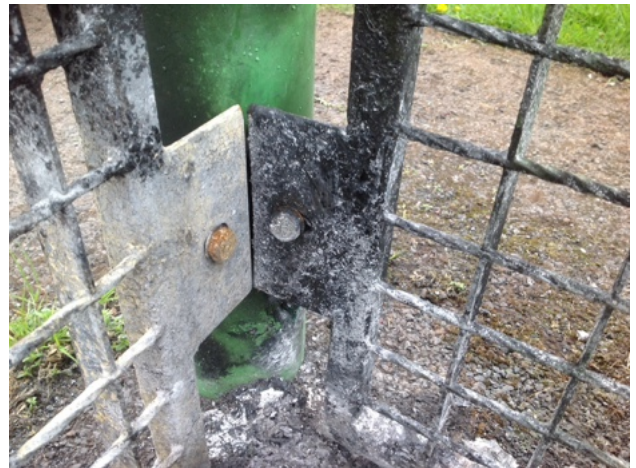
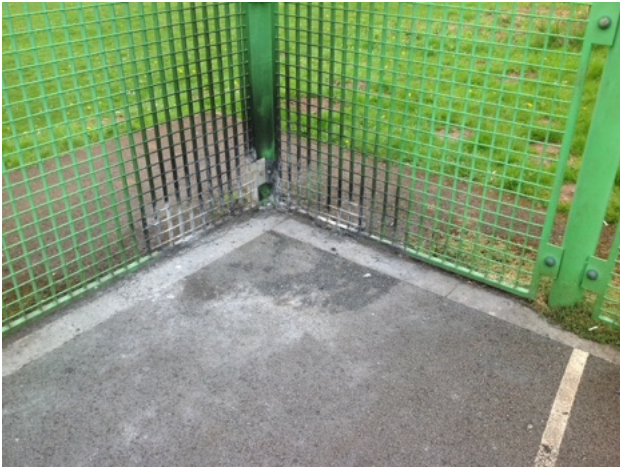
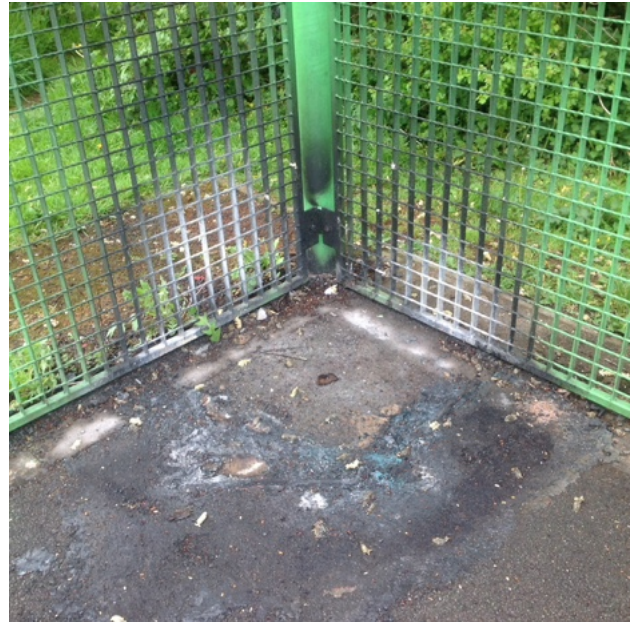
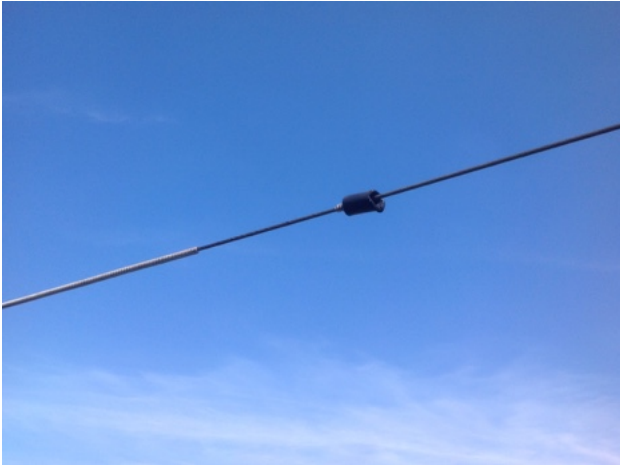
<p>Appendix 27</p> </div> </div>		
Equipment Findings	Safe	<p>A small fire has caused minor damage to the ball court surface, an additional fire in the opposite corner has caused minor damage to the ball court surface and paintwork on the steel grid</p> <p>The Spring stopper at the end of the cable ride has broken, this is not currently a safety issue but may deteriorate further with time, monitor and plan to replace at convenient time in the future</p>

<p>Appendix 31</p> </div> </div>		
Safety Surfacing Findings	Safe	
Recommendations	Yes	Plan ahead to replace cable ride spring
<b>Other comments</b>		Score (0/1) 0%
		No
<b>Inspector Sign Off</b>
