# Play Area / Equipment Operational Inspection

LLANHARRY COMMUNITY COUNCIL

Score	100%	Flagged items	0	Actions	0
Document No.	000078				
Audit Title	LLANHARRY COMMUNITY COUNCIL				
Client / Site	Llanharry Recreation Ground				
Conducted on	04.04.2022 08:30 BST				
Prepared by	Jerry Widdas				
Location	Llanharry				
Personnel	Jerry Widdas

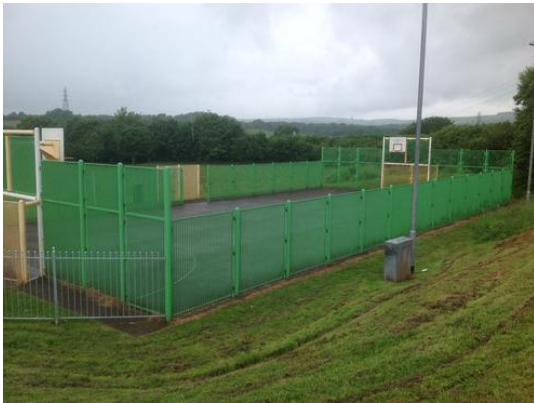
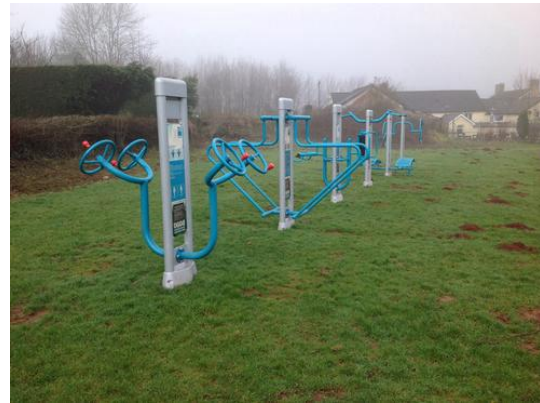
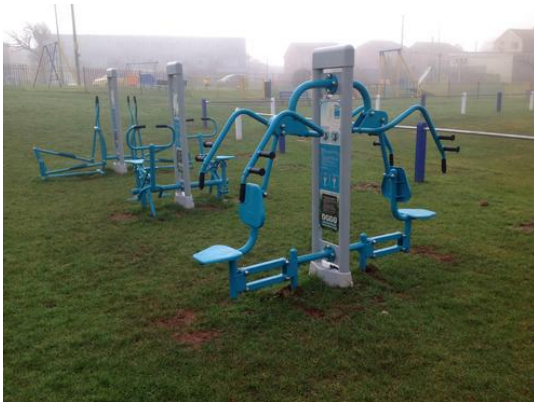
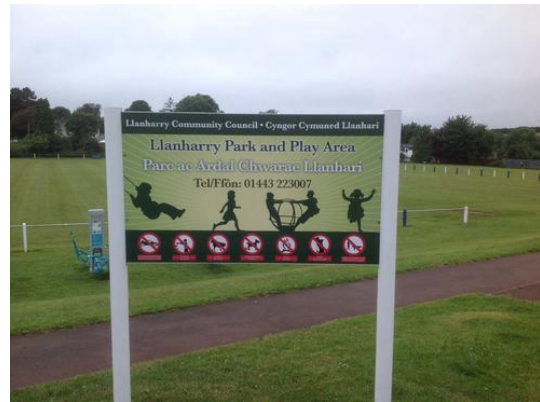
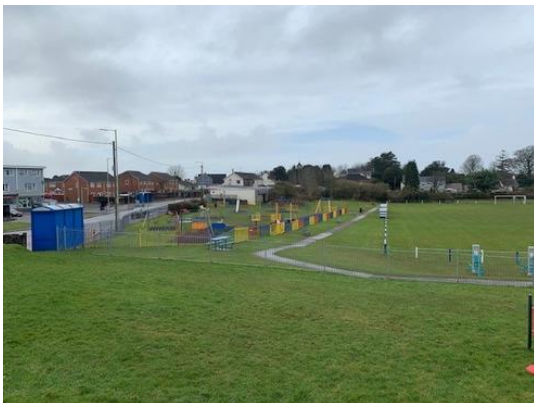
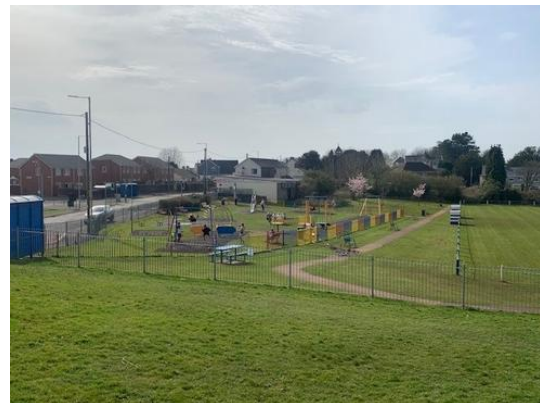
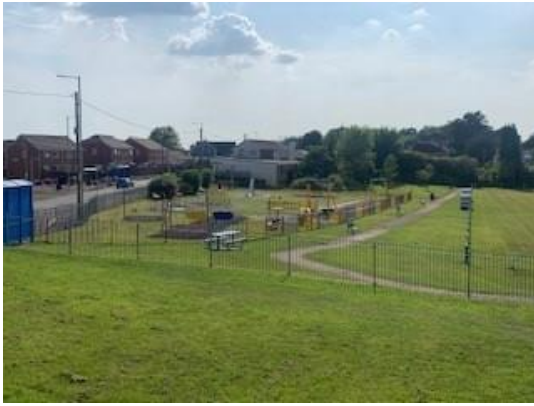
The recreation ground consists of a play area fenced by steel bow top fencing with self closing gates

A MUGA kick about area and a youth shelter

Both areas are accessed by Tarmac pathways

Benches and picnic tables are located within the play area and also outside the play area boundary

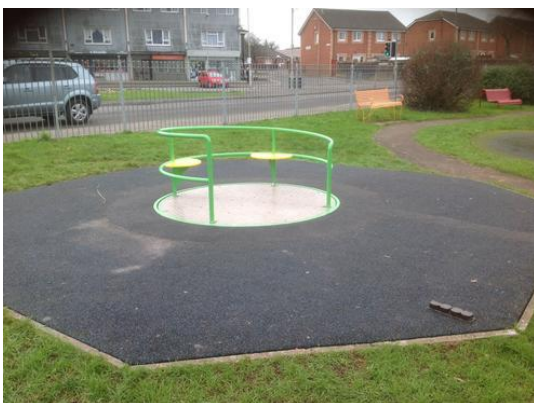
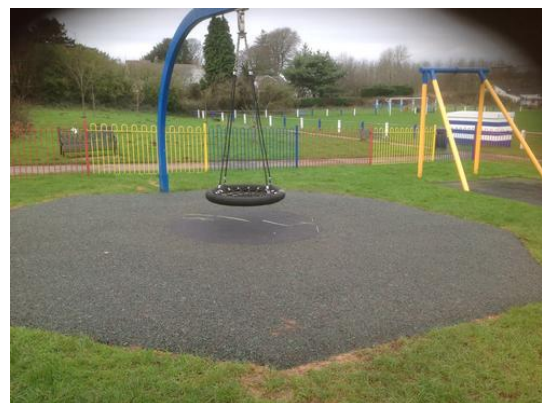
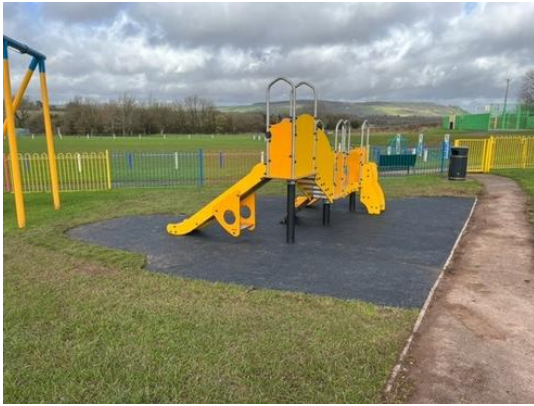
At the time of inspection all the equipment was found to be in a safe and useable condition

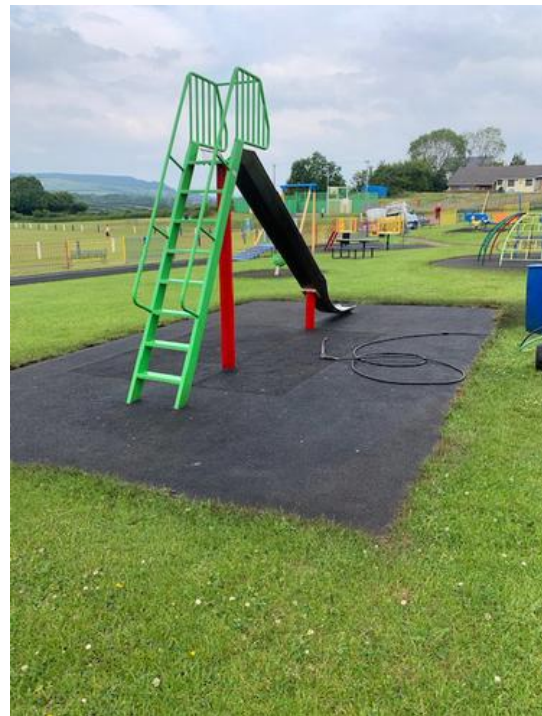
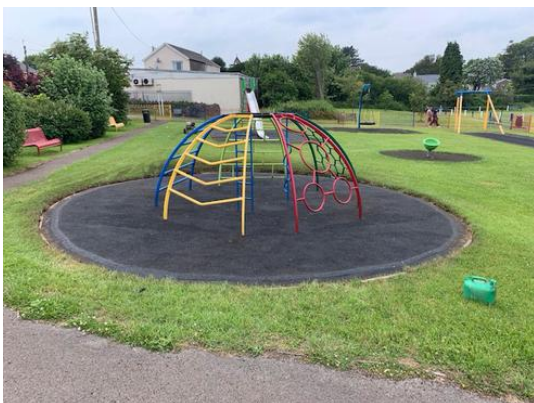
All items of play equipment are located on wet pour rubber safety surfacing

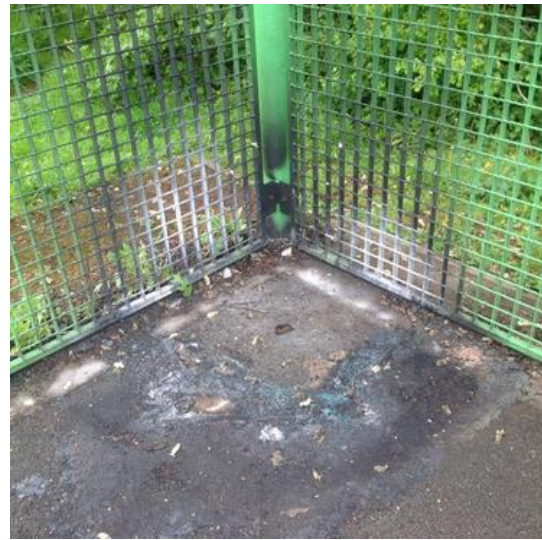
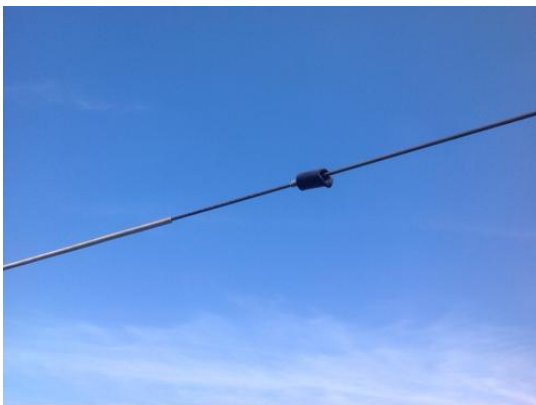
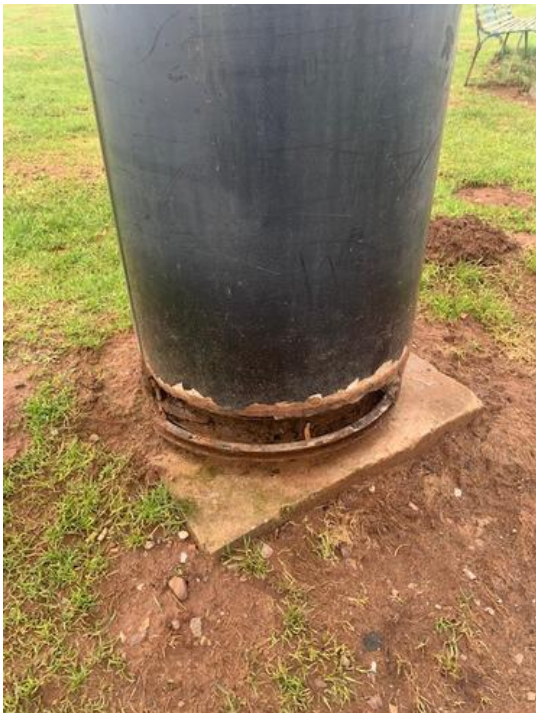
The flat seats on the swing are starting to show the steel insert, monitor for further deterioration and replace

One of the basket swing suspension ropes has been wrapped, monitor

A small fire has caused minor damage to the ball court surface, an additional fire in the opposite corner has caused minor damage to the ball court surface and paintwork on the steel grid

The Spring stopper at the end of the cable ride has broken, this is not currently a safety issue but may deteriorate further with time, monitor and plan to replace at convenient time in the future.

There is some wear on the toddler swing chains, monitor and plan for replacement in the future

There is a rubber cover missing from one of the sit up benches

The three round litter bins surrounding the football field have advanced corrosion

monitor items noted
