# Play Area / Equipment Operational Inspection

LLANHARRY COMMUNITY COUNCIL

Score	100%	Flagged items	0	Actions	0
Document No.	000078				
Audit Title	LLANHARRY COMMUNITY COUNCIL				
Client / Site	Llanharry Recreation Ground				
Conducted on	06.05.2022 13:30 BST				
Prepared by	Jerry Widdas				
Location	Llanharry				
Personnel	Jerry Widdas

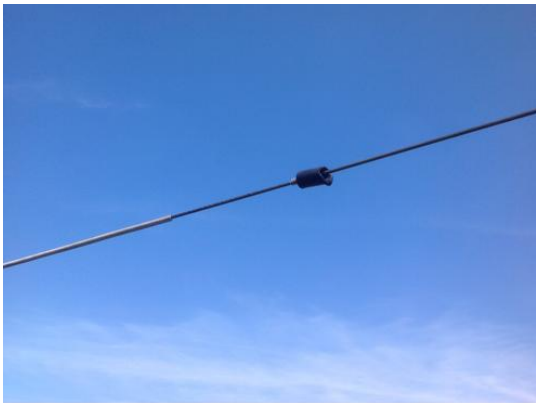
Photo 31

The Spring stopper at the end of the cable ride has broken, this is not currently a safety issue but may deteriorate further with time, monitor and plan to replace at convenient time in the future.
