# Play Area / Equipment Operational Inspection

LLANHARRY COMMUNITY COUNCIL

Score	100%	Flagged items	0	Actions	0
Document No.	000078				
Audit Title	LLANHARRY COMMUNITY COUNCIL				
Client / Site	Llanharry Recreation Ground				
Conducted on	04.10.2022 16:25 BST				
Prepared by	Jerry Widdas				
Location	Llanharry				
Personnel	Jerry Widdas

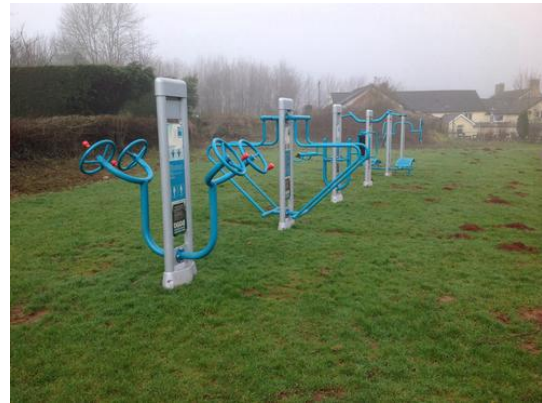
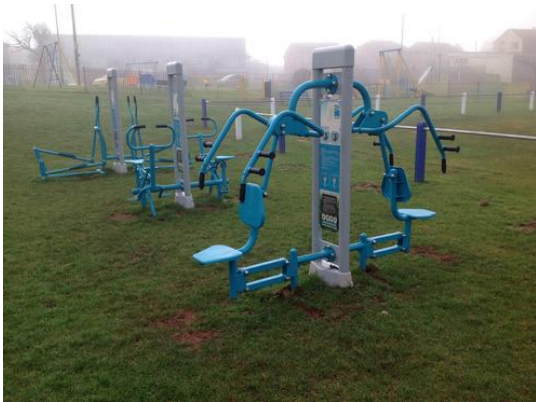
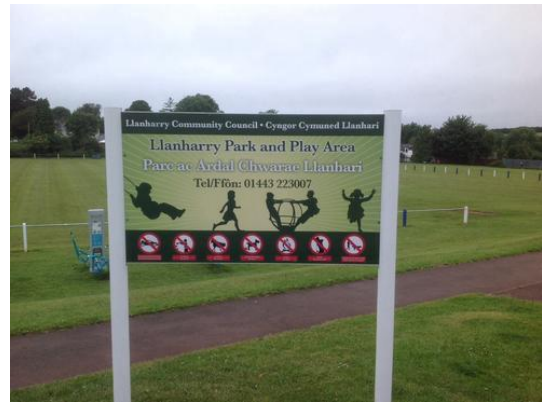
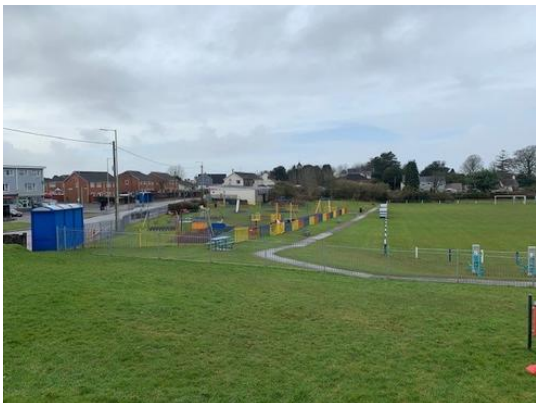
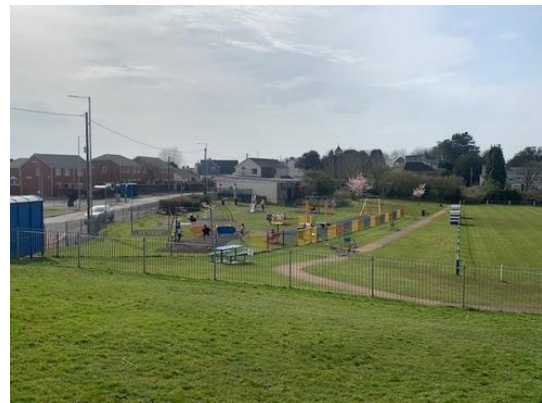
The recreation ground consists of a play area fenced by steel bow top fencing with self closing gates

A MUGA kick about area and a youth shelter

Both areas are accessed by Tarmac pathways

Benches and picnic tables are located within the play area and also outside the play area boundary

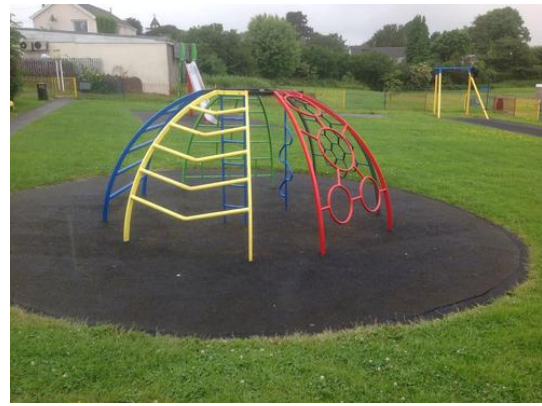
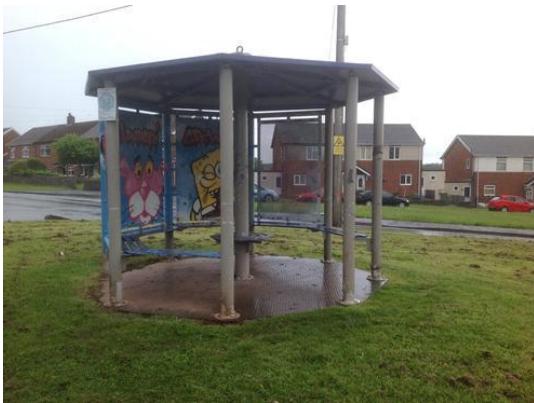
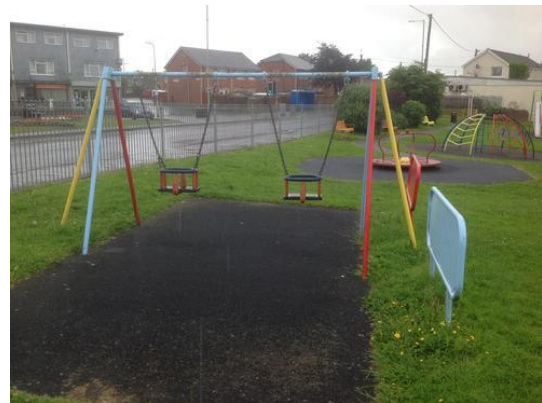
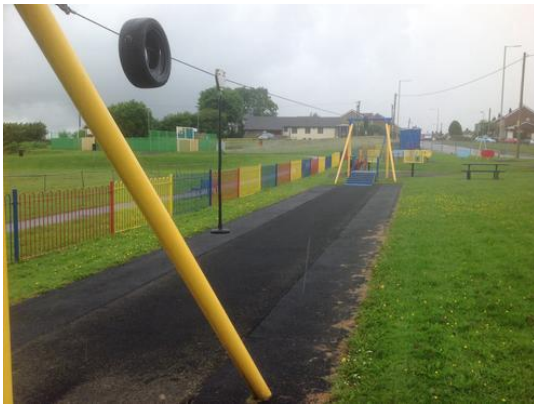
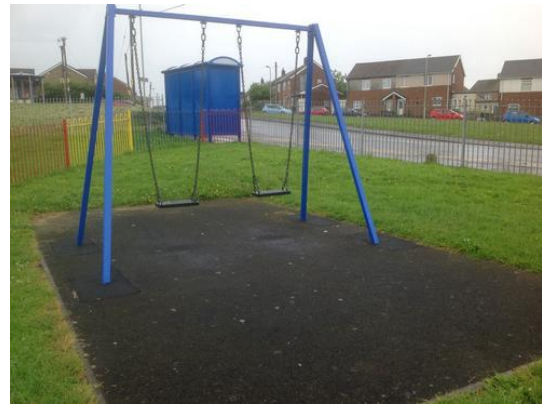
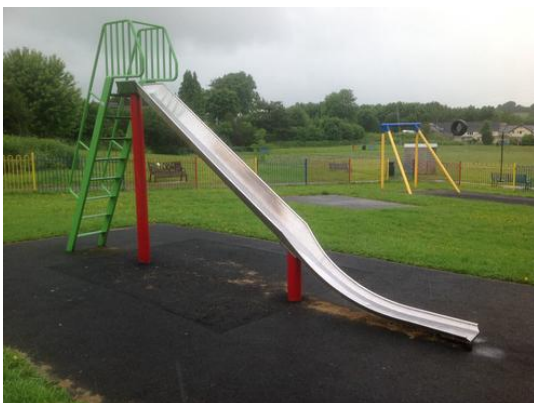
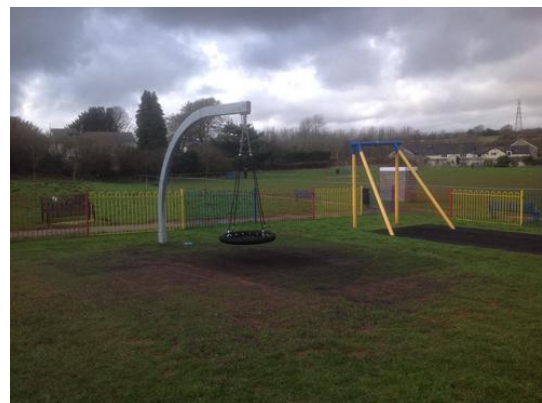
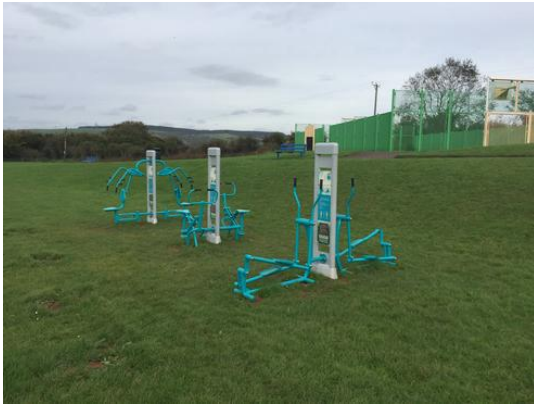
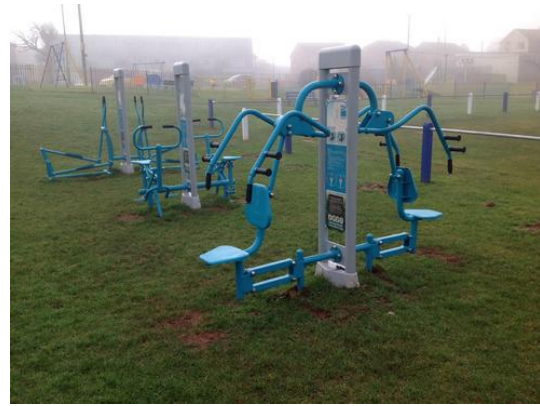
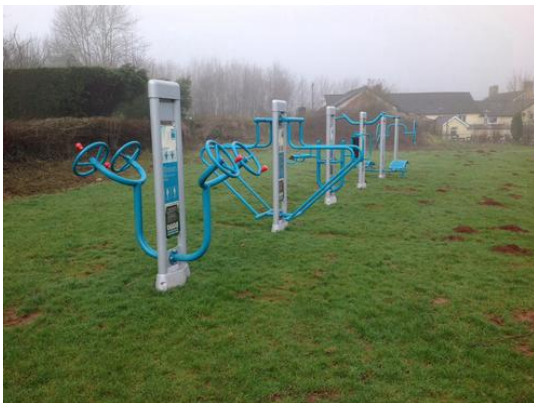
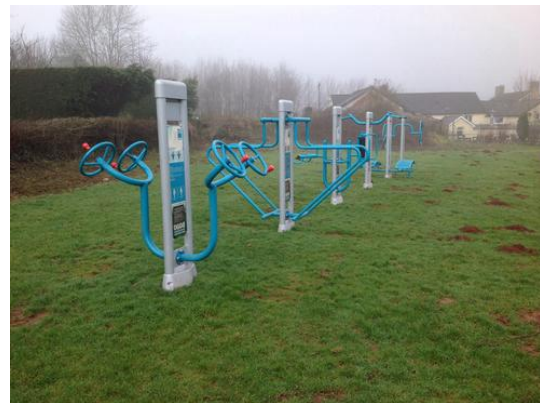
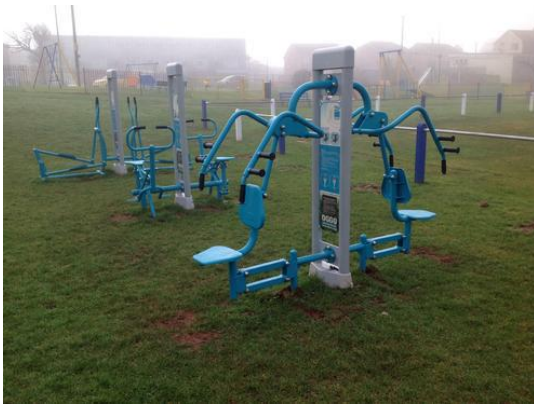
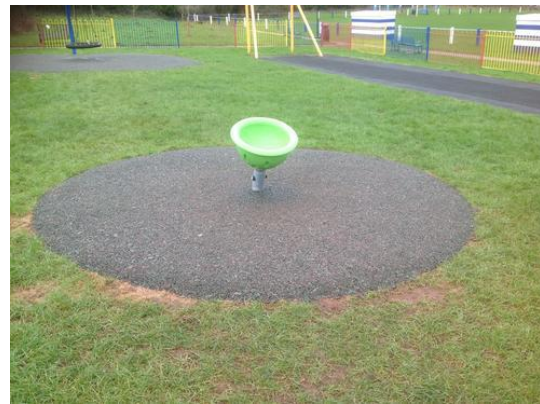
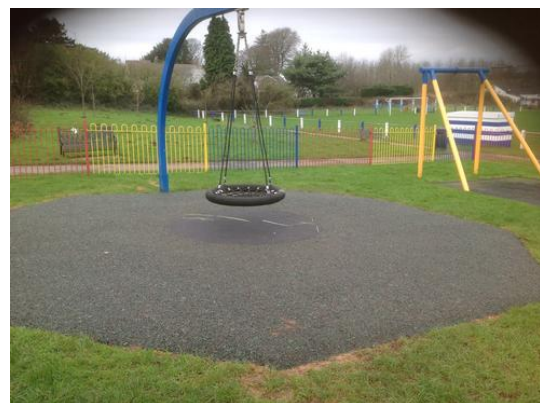
MUGA area supplied by PPL date unknown

1 X 2 seat swing supplied and installed by Urban Recreation in 2016

1 X Traditional cradle seat swing Wicksteed Leisure

1 X Traditional Igloo climber Wicksteed Leisure

1 X Wheelchair roundabout supplied and installed Urban Recreation Dec 2018

1 X Multiplayer Unit Proludic installed Feb 2022

1 X Steel cable ride Record Play

1 X Freestanding slide Record Play

2 X Spring animals Fahr Industries installed Feb 2022

1 X Teen Shelter David Ogilvie Engineering

1 X Cantilever Swing supplied Urban Recreation 2016

9 X Fitness Items supplied Urban Recreation October 2017

1 X Spinning Cup supplied and installed Urban Recreation Dec 2018

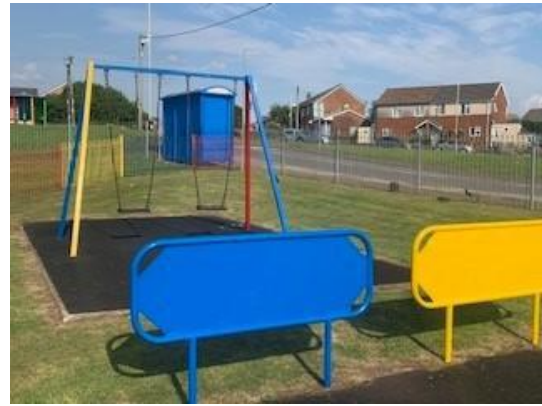
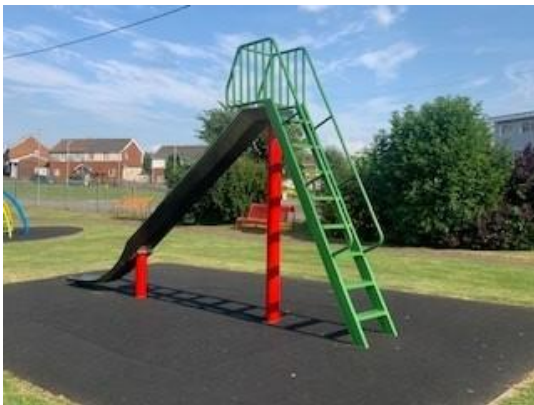
At the time of inspection all the equipment was found to be in a safe and useable condition

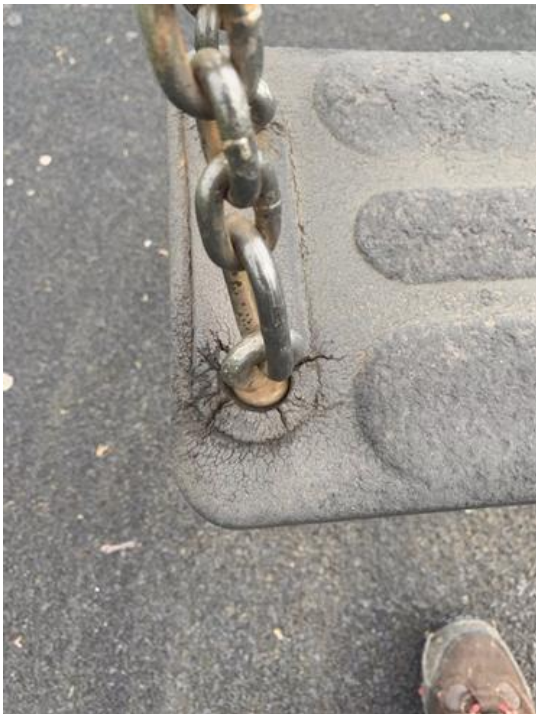
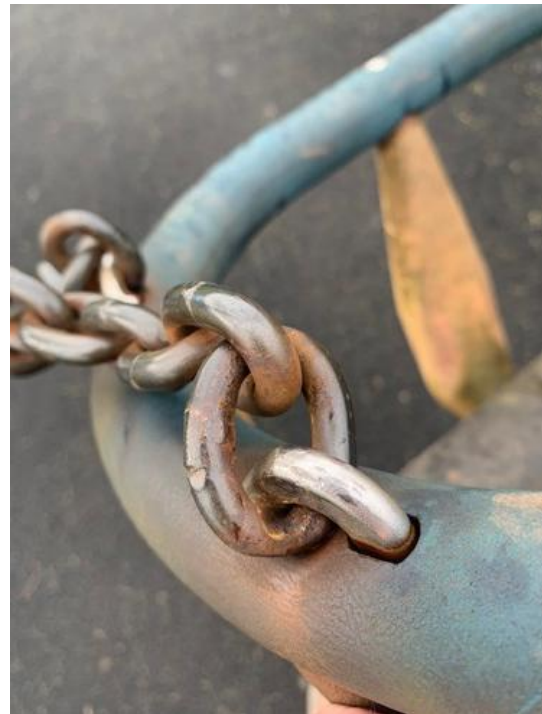
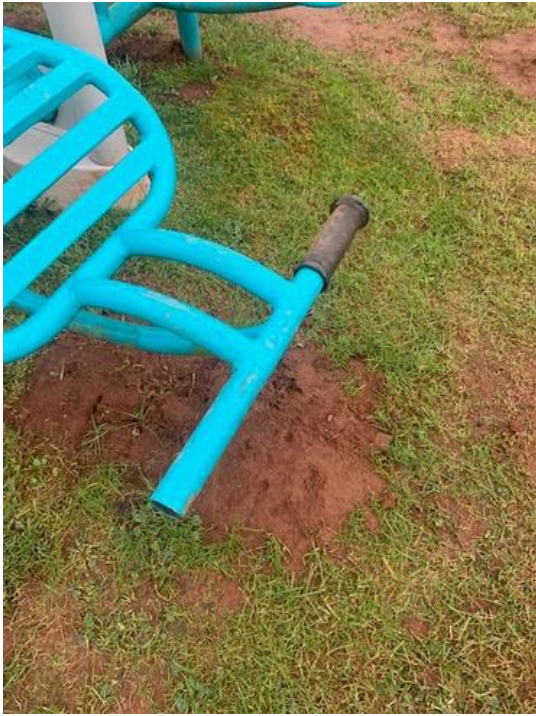
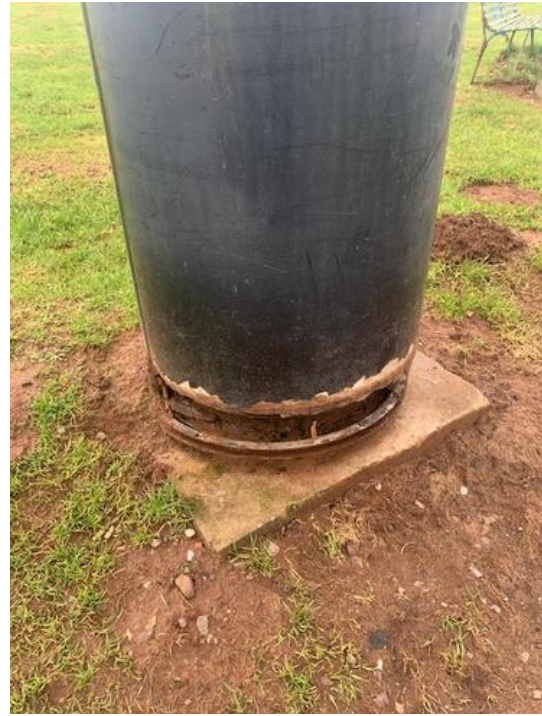
The flat seats on the swing are starting to show the steel insert, monitor for further deterioration and replace

One of the basket swing suspension ropes has been wrapped, monitor

A small fire has caused minor damage to the ball court surface, an additional fire in the opposite corner has caused minor damage to the ball court surface and paintwork on the steel grid

There is some wear on the toddler swing chains, monitor and plan for replacement in the future

There is a rubber cover missing from one of the sit up benches

The three round litter bins surrounding the football field have advanced corrosion

monitor items noted
