# Safety Inspection Report

Annual Inspection

## Ty Isaf Play Area

09 June 2022

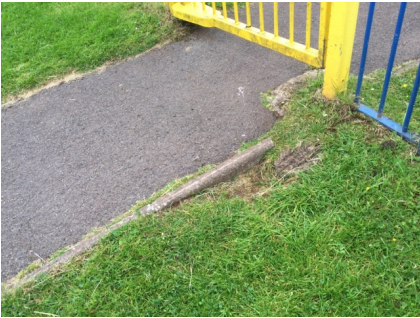
Trip points on the surface.

Make level.

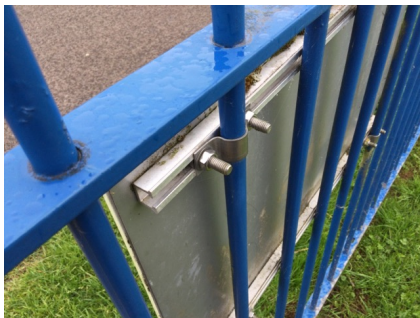
Projecting bolt thread.

Cut off and file down to remove sharp edges or use the correct length of bolt.

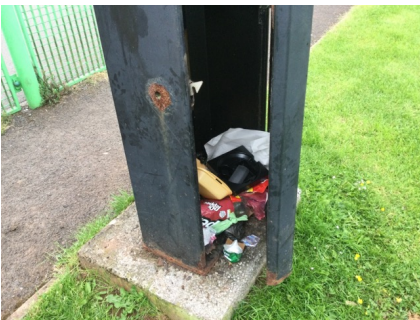
Bin liner is missing.

Replace the missing liner.

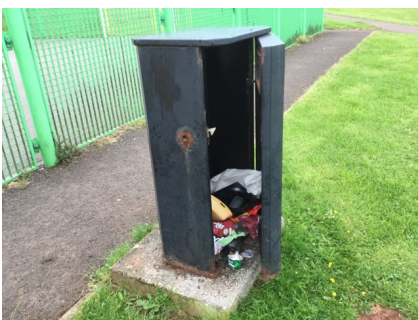
The item is unlocked.

Lock.

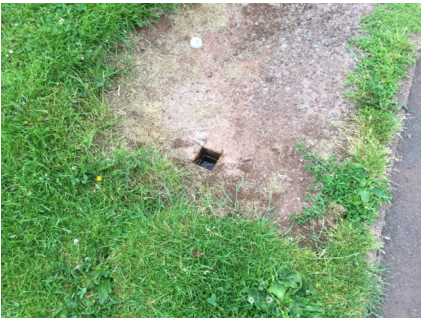
Description
Surface has holes in it.
Tasks
Repair.

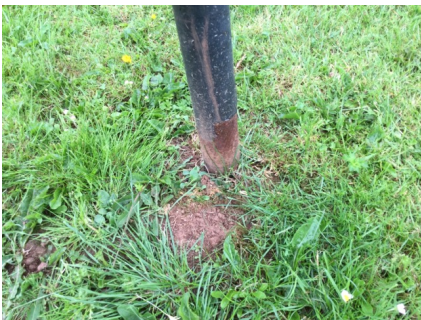
Item has corrosion.

Treat and repair.

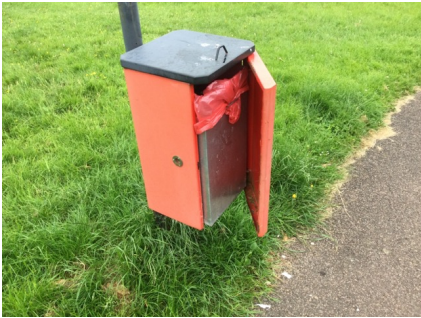
The item is unlocked.

Lock.

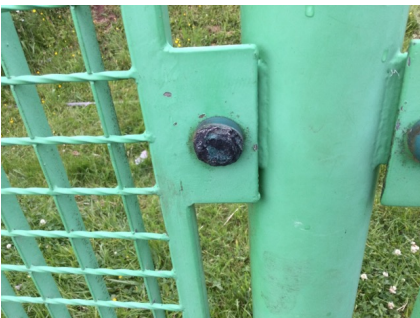
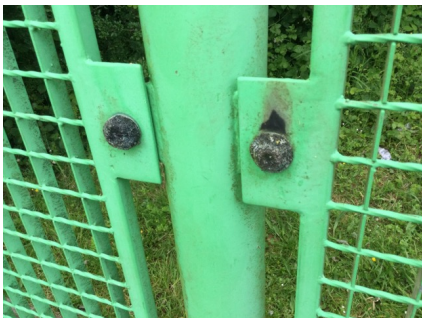
Vandalised (arson).

Repair.

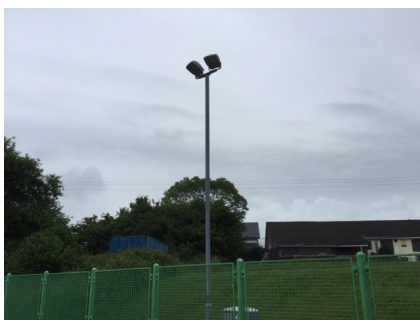
Item was not inspected on this occasion.

Inspection of the floodlights does not form part of this report. Arrange for an inspection by a suitably qualified lighting engineer.

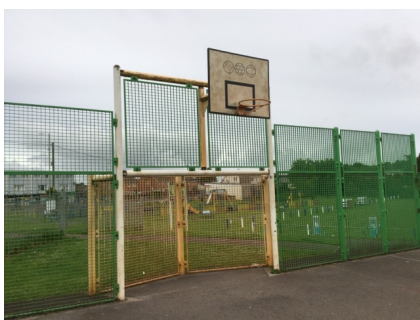
A warning notice should be fitted to all sports related equipment with the words "do not climb on the framework or nets", "do not hang on the ring" (if provided) and "do not wear rings or other jewellery as these can get caught and cause injury".

Fit warning notice.

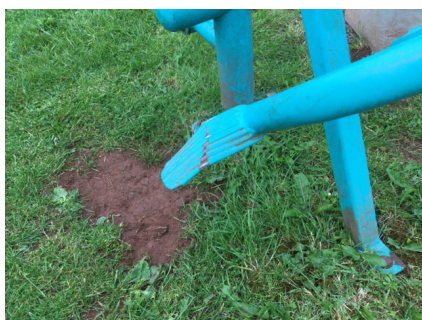
Item is bent.

Monitor.

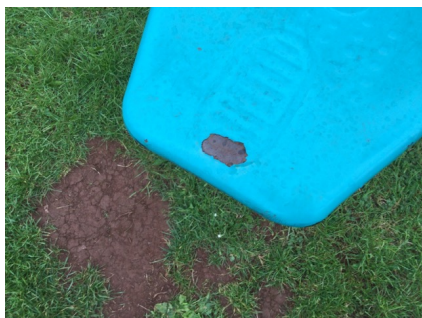
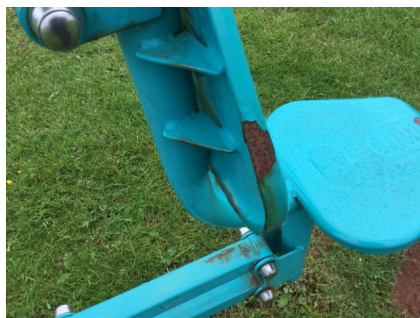
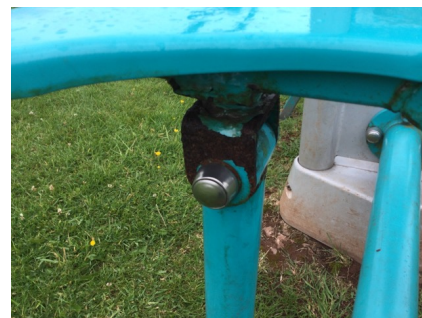
Item has corrosion.

Treat and repair.

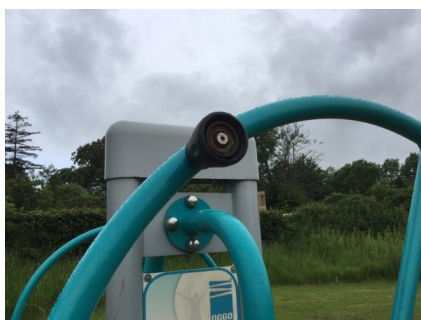
Cap missing.

Replace.

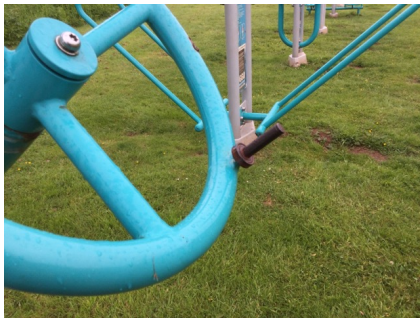
Hand grip is missing.

Replace missing grip.

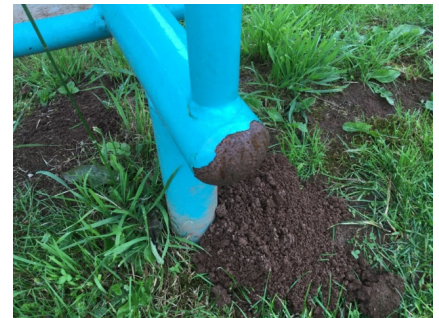
Item has corrosion.

Treat and repair.

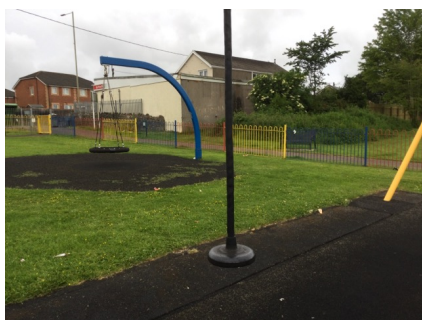
Chain covers prevent a thorough inspection of all chain links.

Remove chain covers to inspect according to manufacturer's instructions.

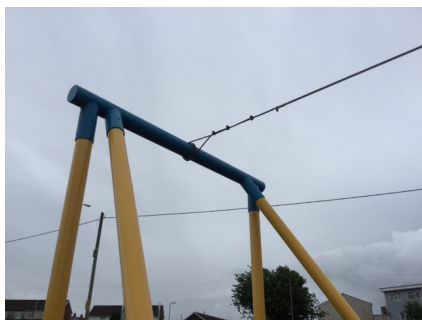
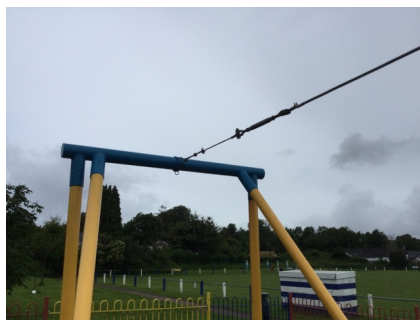
Cables have been known to fail under load due to wear and corrosion. This is generally where the cable enters into a tube, top bar or similar, where the wire is in contact and wears and frays over time, but can happen anywhere on the cable. It is important to carry out a full dismantling inspection at least once per year. Damaged cables require replacement. This cannot be determined during an annual inspection, and is excluded from our inspection. This finding is generically high risk and action is required. Refer to the manufacturer's instructions to ensure the correct check is carried out.

Conduct an appropriate dismantling inspection according to the manufacturer's instructions.

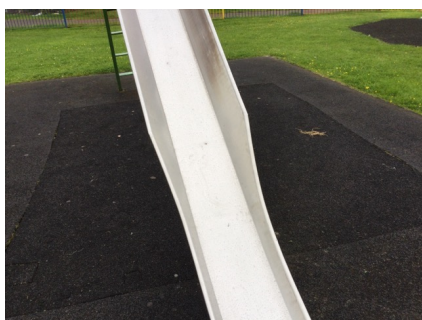
Item is bent.

Chute dented - Monitor.

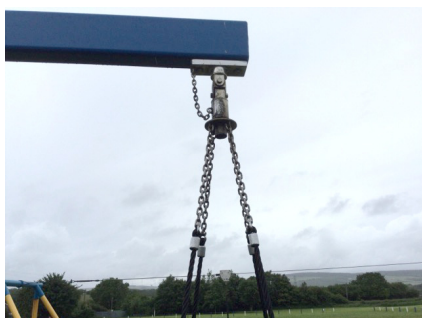
The supporting components should be dismantled and inspected according to the manufacturer's instructions. This will need doing on a regular basis.

Dismantle and inspect according to manufacturer's instructions.

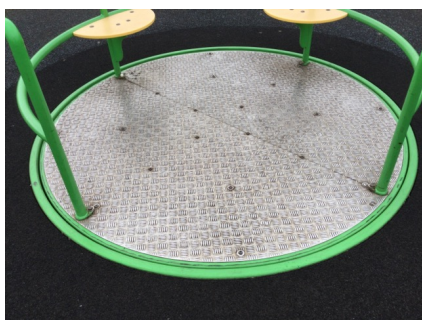
There is wear in the bearings.

Monitor and replace when necessary.

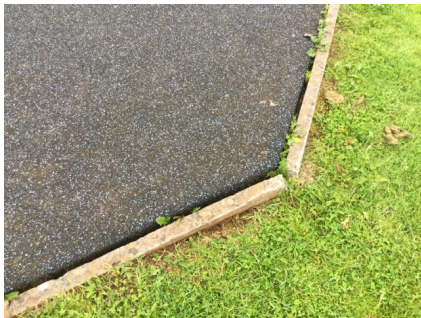
Shrinkage / separation of the surface. This may give a trip hazard.

Repair.

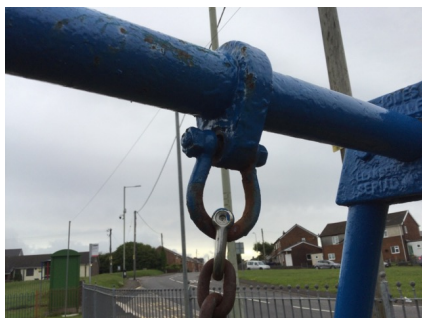
There is wear in the bushes.

Remove shackle bolt and check bush and shackle pin wear, replacing as necessary.

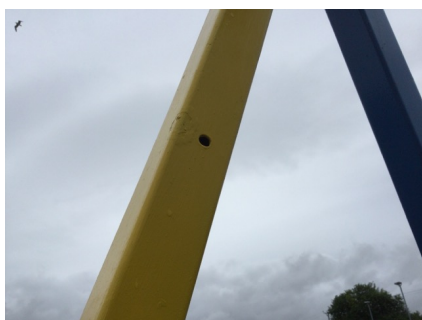
Cap missing.

Replace.
