# Play Area / Equipment Operational Inspection

LLANHARRY COMMUNITY COUNCIL

Score	100%	Flagged items	0	Actions	0
Document No.	000078				
Audit Title	LLANHARRY COMMUNITY COUNCIL				
Client / Site	Llanharry Recreation Ground				
Conducted on	01.09.2022 10:25 BST				
Prepared by	Jerry Widdas				
Location	Llanharry				
Personnel	Jerry Widdas

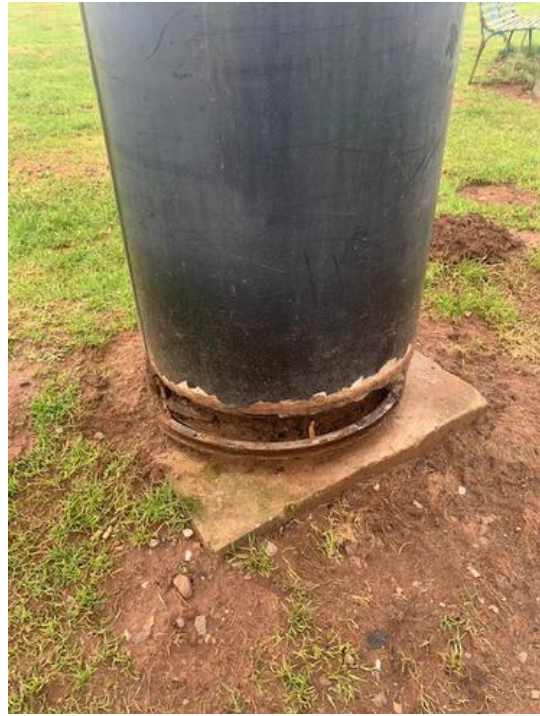
Photo 34

The three round litter bins surrounding the football field have advanced corrosion
