Play Area / Equipment Operational Inspection

LLANHARRY COMMUNITY COUNCIL

Client / Site	Llanharry Recreation Ground
---------------	-----------------------------

Conducted on	02.12.2022 11:30 GMT
--------------	----------------------

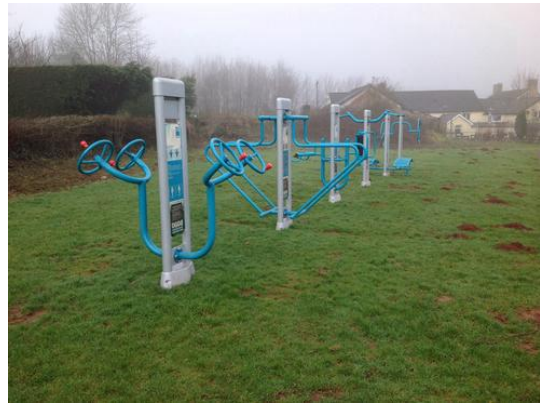
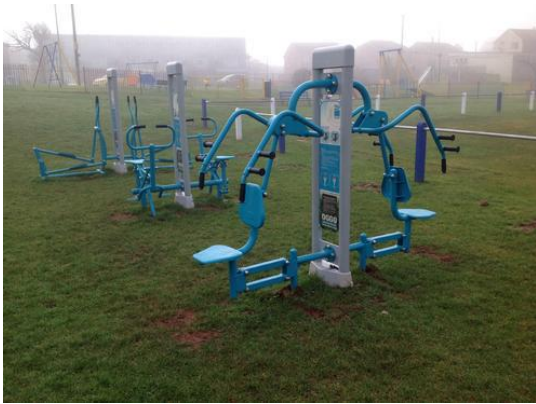
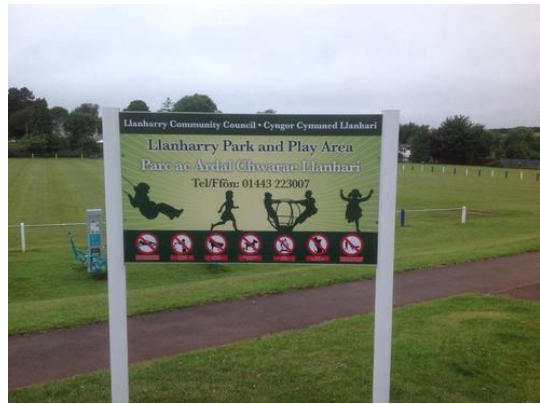
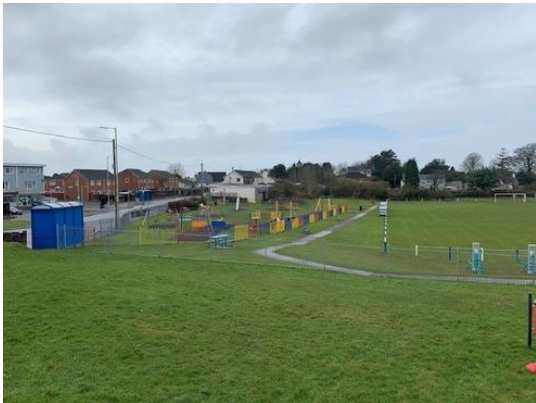
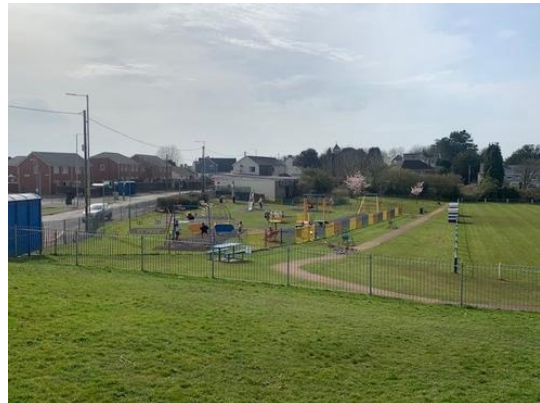
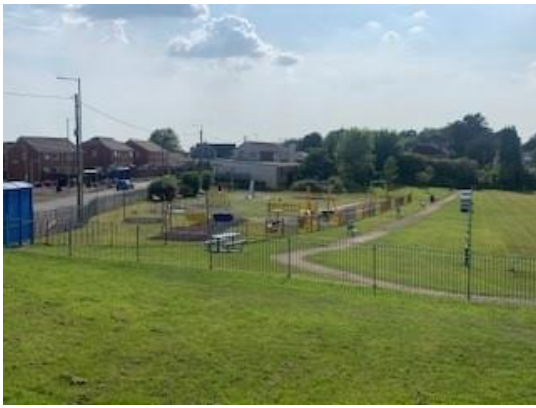
The recreation ground consists of a play area fenced by steel bow top fencing with self closing gates

A MUGA kick about area and a youth shelter

Both areas are accessed by Tarmac pathways

Benches and picnic tables are located within the play area and also outside the play area boundary

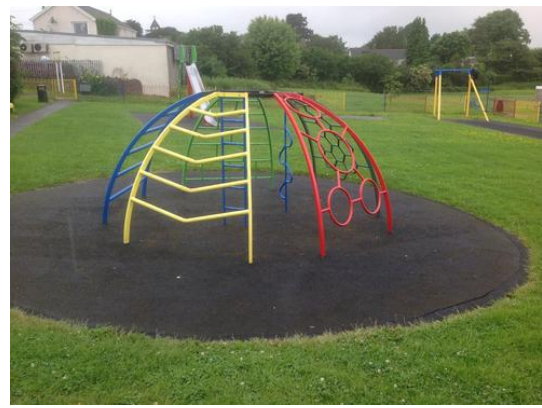
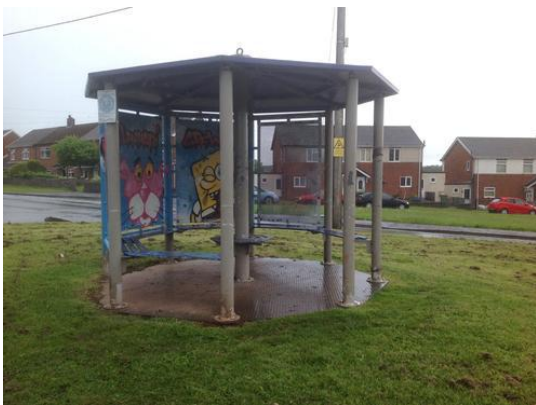
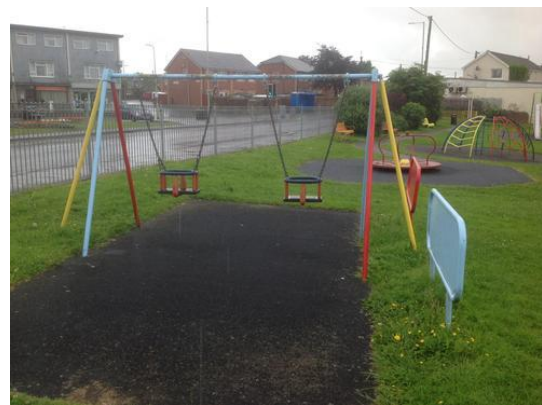
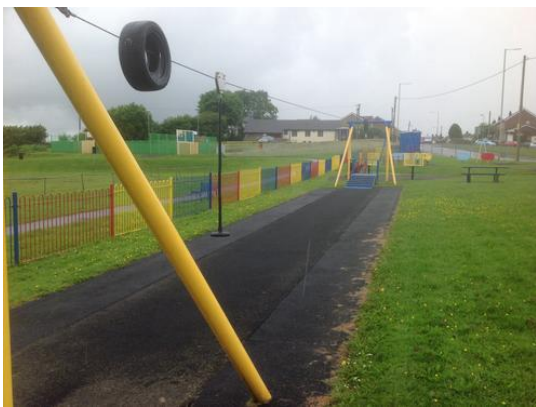
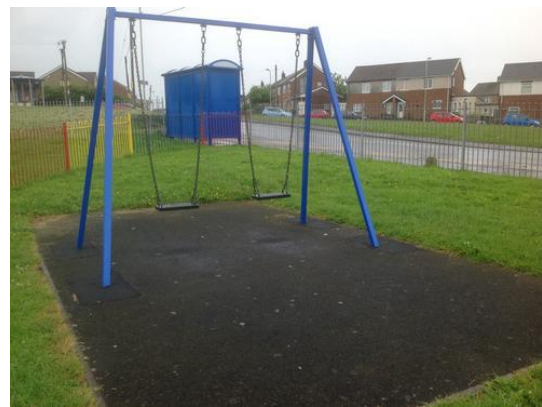
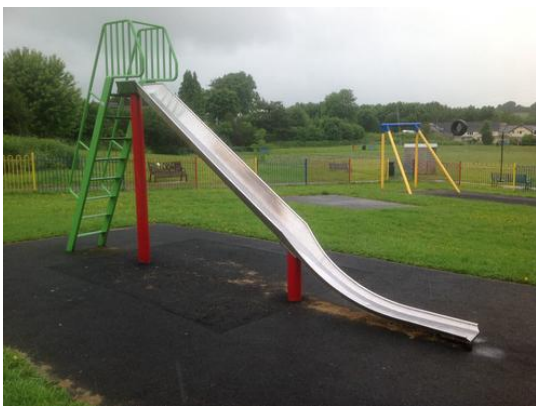
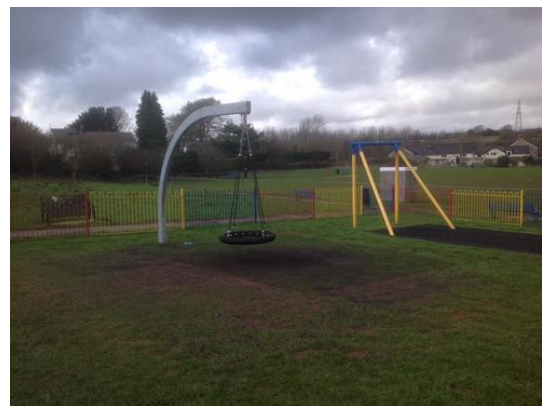
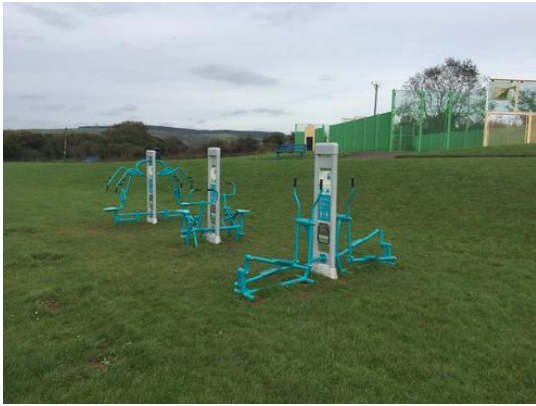
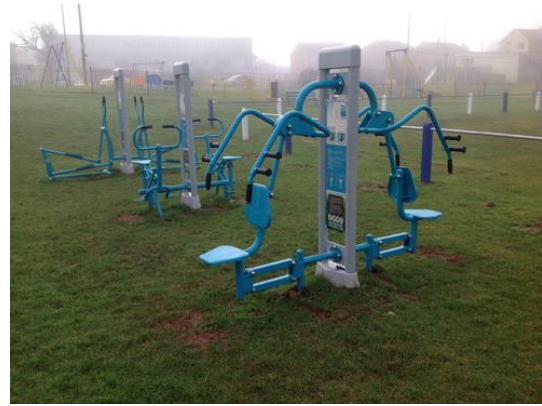
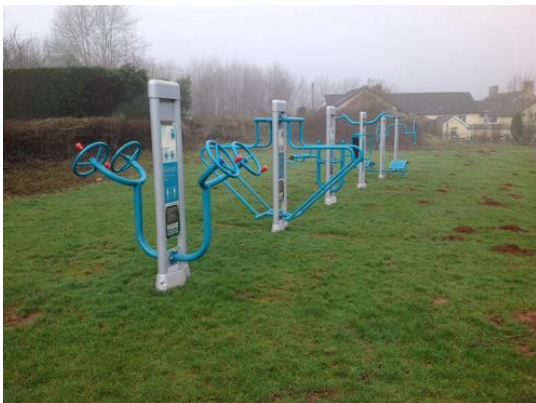
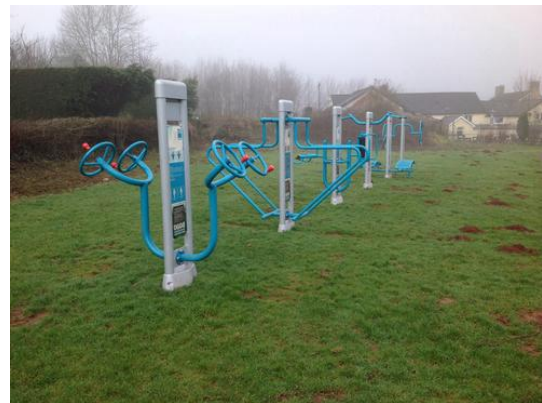
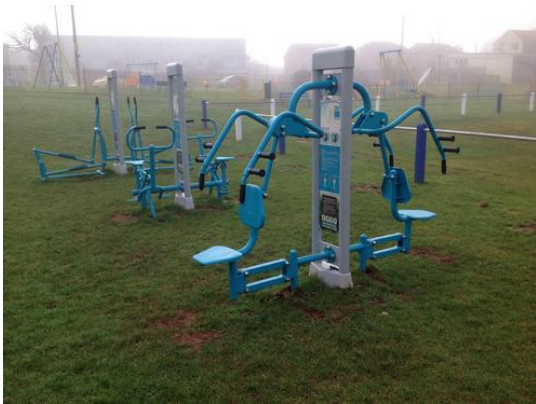
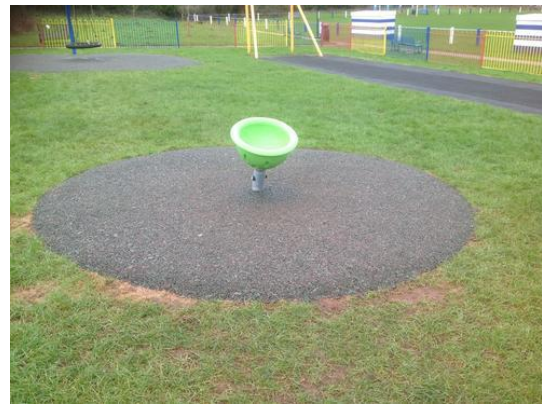
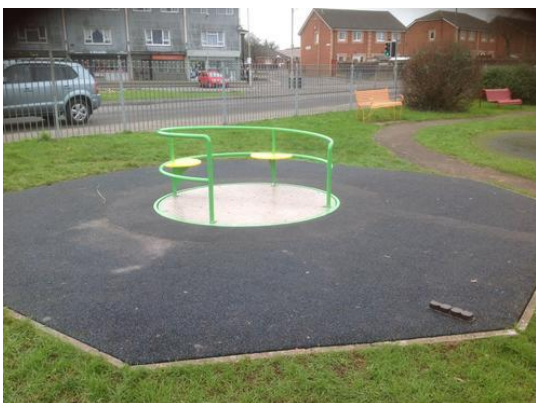
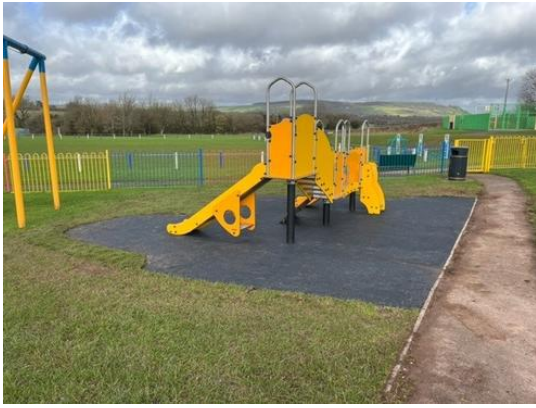
MUGA area supplied by PPL date unknown

1 X 2 seat swing supplied and installed by Urban Recreation in 2016

1 X Traditional cradle seat swing Wicksteed Leisure

1 X Traditional Igloo climber Wicksteed Leisure

1 X Wheelchair roundabout supplied and installed Urban Recreation Dec 2018

1 X Multiplayer Unit Proludic installed Feb 2022

1 X Steel cable ride Record Play

1 X Freestanding slide Record Play

2 X Spring animals Fahr Industries installed Feb 2022

1 X Teen Shelter David Ogilvie Engineering

1 X Cantilever Swing supplied Urban Recreation 2016

9 X Fitness Items supplied Urban Recreation October 2017

1 X Spinning Cup supplied and installed Urban Recreation Dec 2018

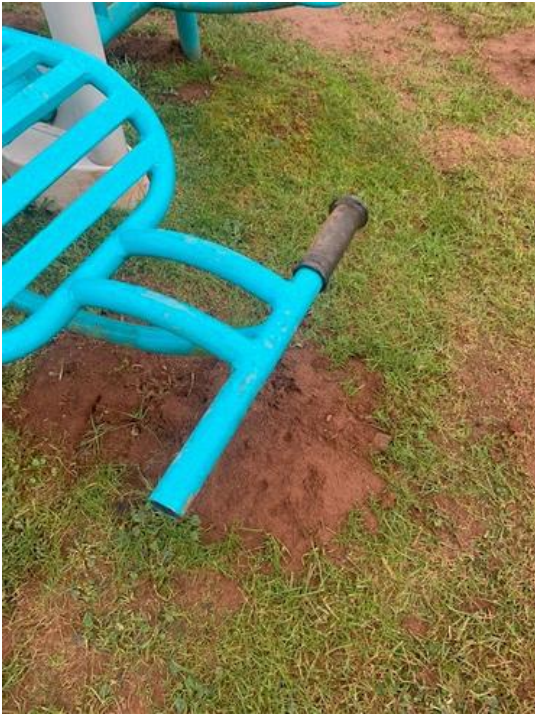
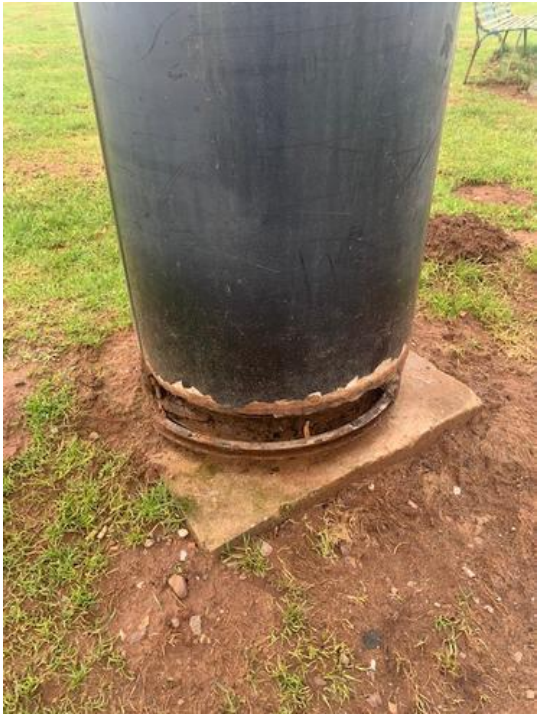
The flat seats on the swing are starting to show the steel insert, monitor for further deterioration and replace

One of the basket swing suspension ropes has been wrapped, monitor

A small fire has caused minor damage to the ball court surface, an additional fire in the opposite corner has caused minor damage to the ball court surface and paintwork on the steel grid

There is some wear on the toddler swing chains, monitor and plan for replacement in the future

There is a rubber cover missing from one of the sit up benches

The three round litter bins surrounding the football field have advanced corrosion

monitor items noted
