Play Area / Equipment Operational Inspection

LLANHARRY COMMUNITY COUNCIL

Client / Site	Llanharry Recreation Ground
---------------	-----------------------------

Conducted on	04.02.2023 15:00 GMT
--------------	----------------------

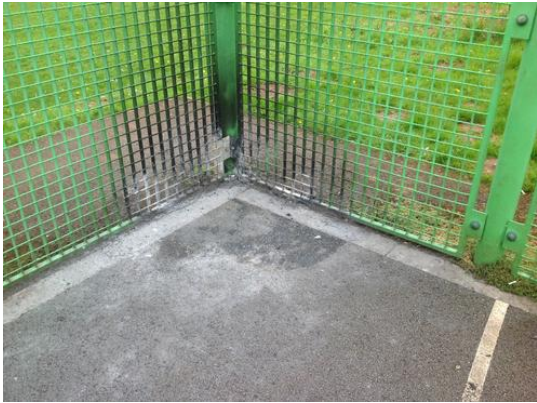
Photo 29

A small fire has caused minor damage to the ball court surface, an additional fire in the opposite corner has caused minor damage to the ball court surface and paintwork on the steel grid

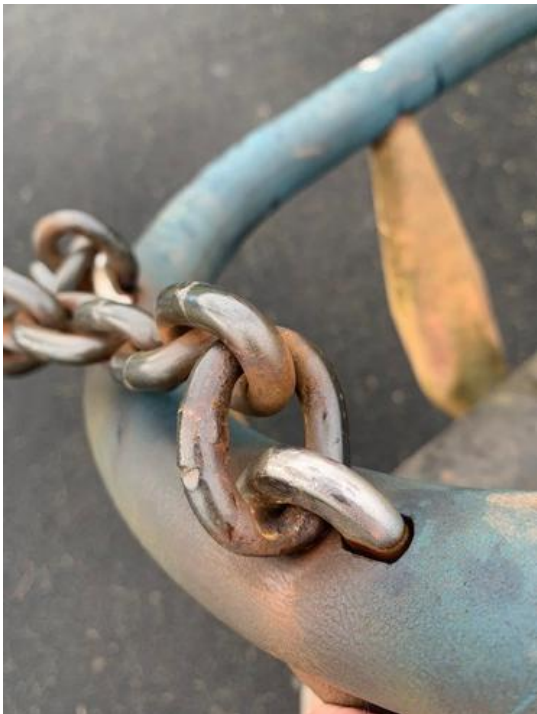
Photo 31

There is some wear on the toddler swing chains, monitor and plan for replacement in the future

monitor items noted

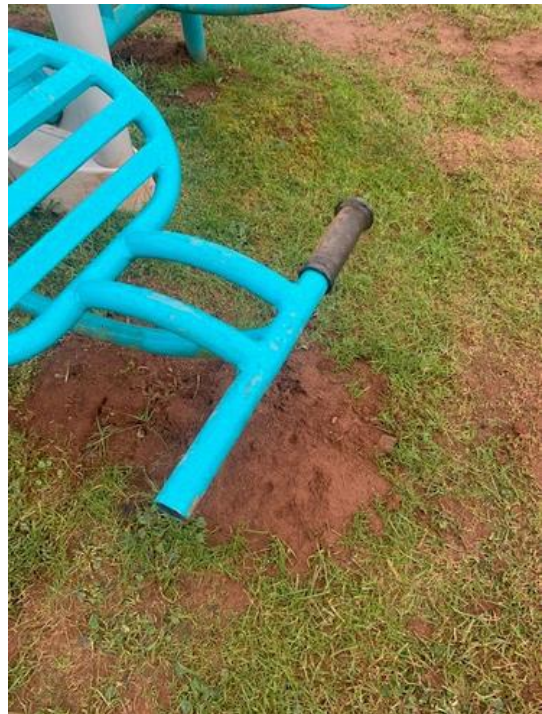
Photo 32

There is a rubber cover missing from one of the sit up benches
