Play Area / Equipment Operational Inspection

LLANHARRY COMMUNITY COUNCIL

Client / Site	Llanharry Recreation Ground
---------------	-----------------------------

Conducted on	09.01.2023 10:30 GMT
--------------	----------------------

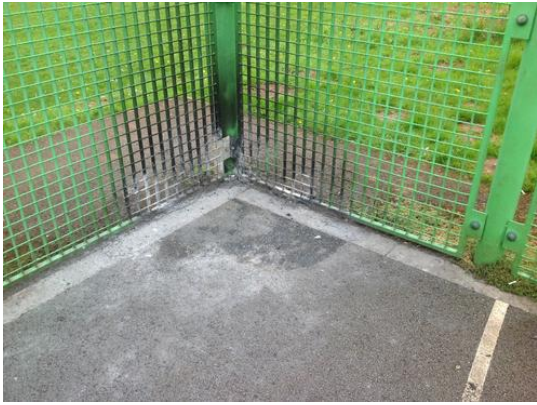
Photo 29

A small fire has caused minor damage to the ball court surface, an additional fire in the opposite corner has caused minor damage to the ball court surface and paintwork on the steel grid

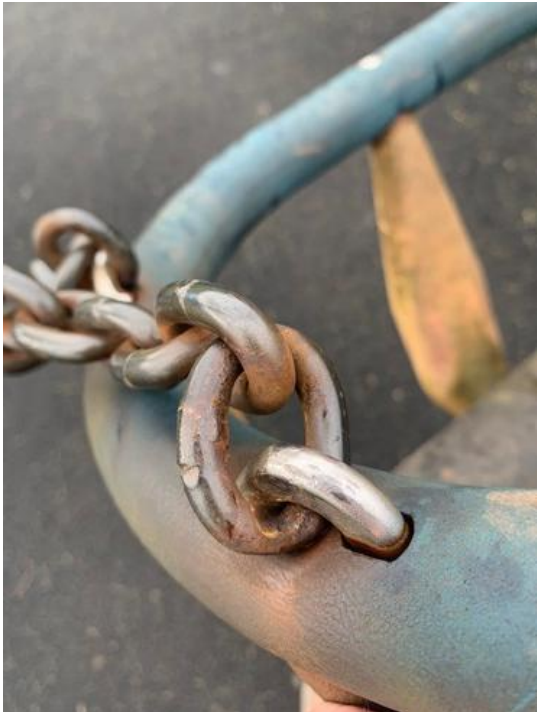
Photo 31

There is some wear on the toddler swing chains, monitor and plan for replacement in the future

monitor items noted

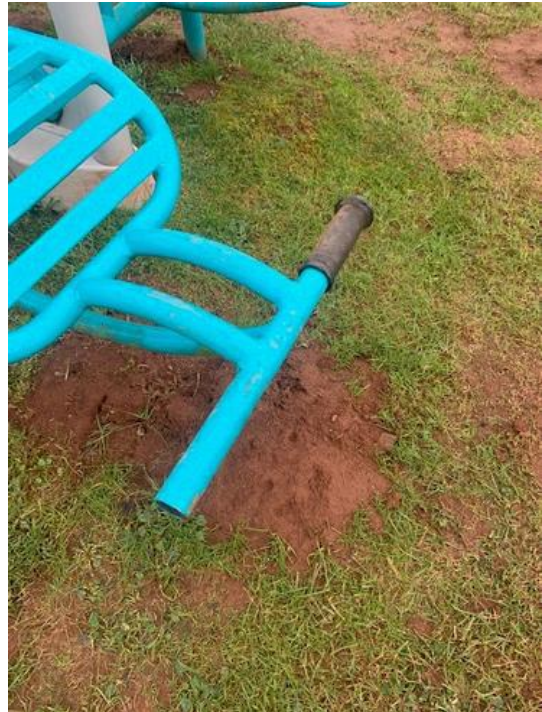
Photo 32

There is a rubber cover missing from one of the sit up benches
