Play Area / Equipment Operational Inspection

LLANHARRY COMMUNITY COUNCIL

Client / Site	Llanharry Recreation Ground
---------------	-----------------------------

Conducted on	02.03.2023 13:30 GMT
--------------	----------------------

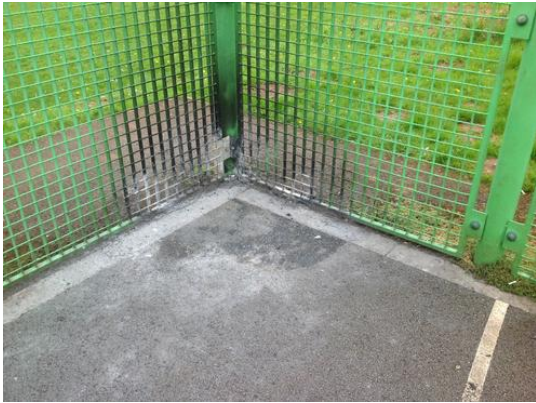
Photo 29

A small fire has caused minor damage to the ball court surface, an additional fire in the opposite corner has caused minor damage to the ball court surface and paintwork on the steel grid

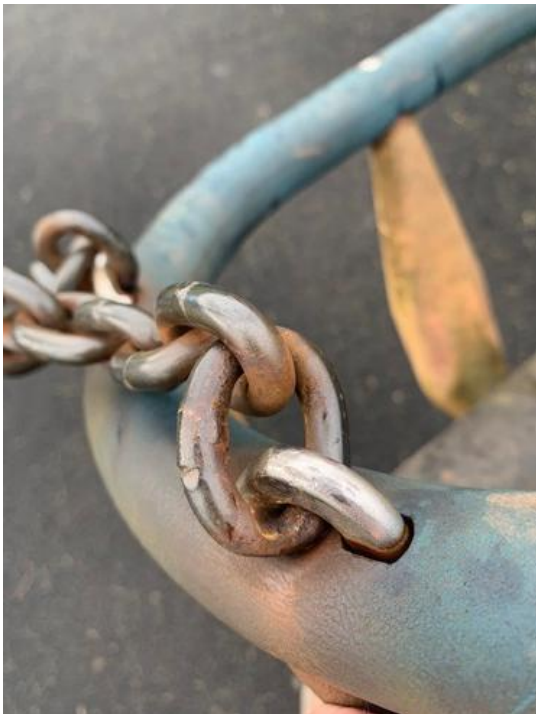
Photo 31

There is some wear on the toddler swing chains, monitor and plan for replacement in the future

monitor items noted

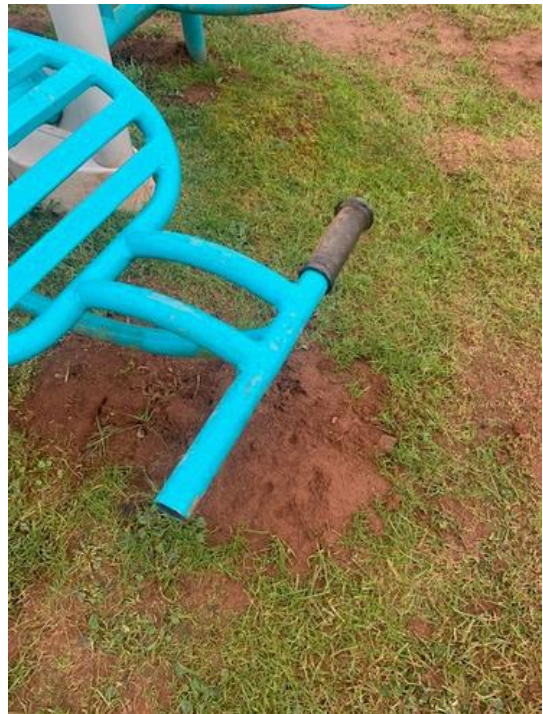
Photo 32

There is a rubber cover missing from one of the sit up benches

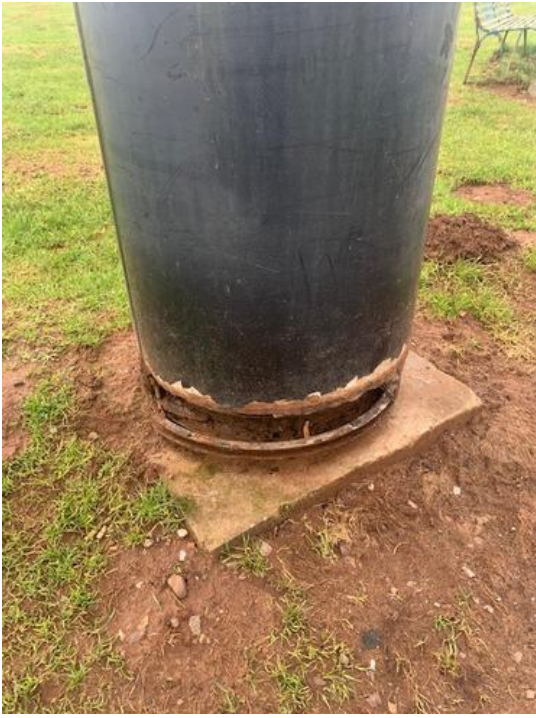
Photo 33

The three round litter bins surrounding the football field have advanced corrosion
