Play Area / Equipment Operational Inspection

LLANHARRY COMMUNITY COUNCIL

Client / Site	Llanharry Recreation Ground
---------------	-----------------------------

Conducted on	03.11.2022 14:30 GMT
--------------	----------------------

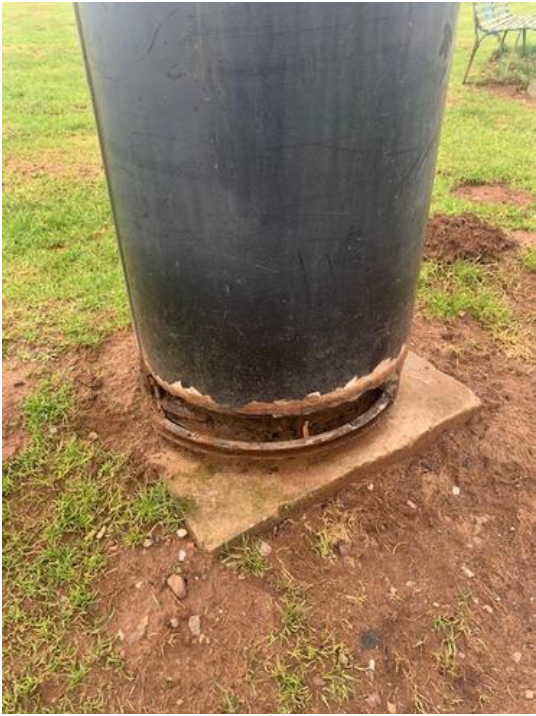
The flat seats on the swing are starting to show the steel insert, monitor for further deterioration and replace

One of the basket swing suspension ropes has been wrapped, monitor

A small fire has caused minor damage to the ball court surface, an additional fire in the opposite corner has caused minor damage to the ball court surface and paintwork on the steel grid

There is some wear on the toddler swing chains, monitor and plan for replacement in the future

There is a rubber cover missing from one of the sit up benches

The three round litter bins surrounding the football field have advanced corrosion

monitor items noted
