Play Area / Equipment Operational Inspection

LLANHARRY COMMUNITY COUNCIL

Client / Site	Llanharry Recreation Ground
---------------	-----------------------------

Conducted on	11.04.2023 14:35 BST
--------------	----------------------

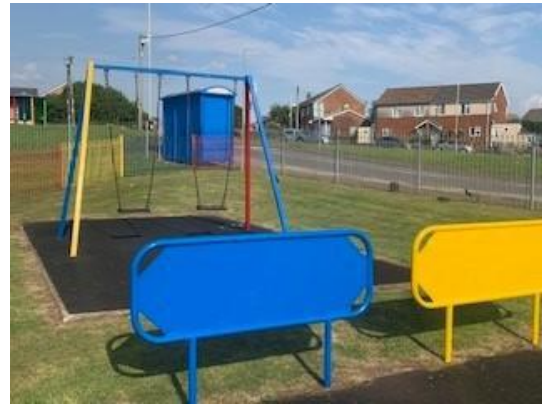
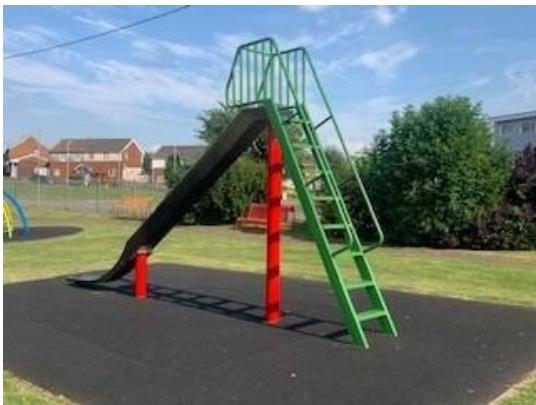
At the time of inspection all the equipment was found to be in a safe and useable condition

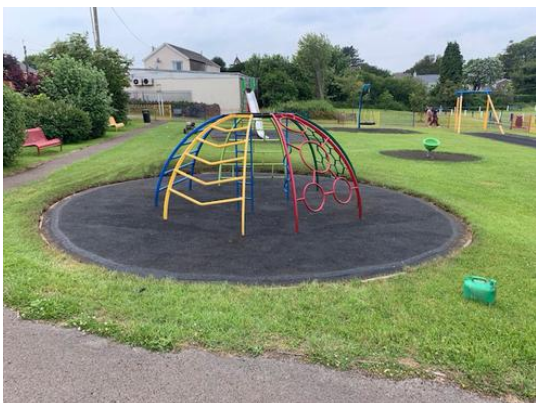
All items of play equipment are located on wet pour rubber safety surfacing

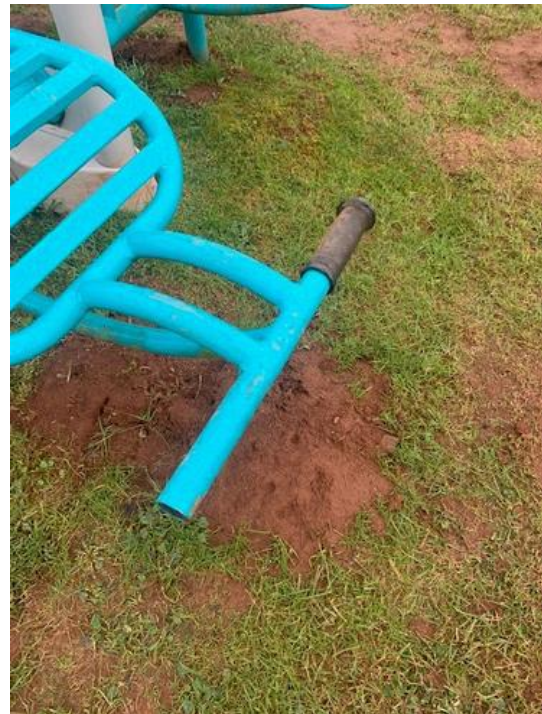
One of the basket swing suspension ropes has been wrapped, monitor

A small fire has caused minor damage to the ball court surface, an additional fire in the opposite corner has caused minor damage to the ball court surface and paintwork on the steel grid

There is some wear on the toddler swing chains, monitor and plan for replacement in the future

There is a rubber cover missing from one of the sit up benches

At the time of inspection the access gate was not self closing

The stopper spring on the cable ride has once again started to break, would suggest using a heavier duty spring next time it is changed.

monitor items noted
