Play Area / Equipment Operational Inspection

LLANHARRY COMMUNITY COUNCIL

Client / Site	Llanharry Recreation Ground
---------------	-----------------------------

Conducted on	04.08.2023 15:22 BST
--------------	----------------------

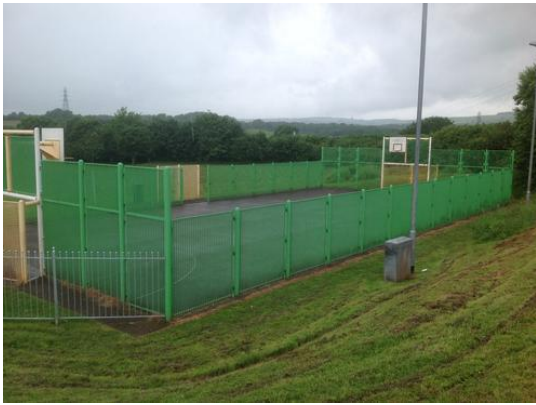
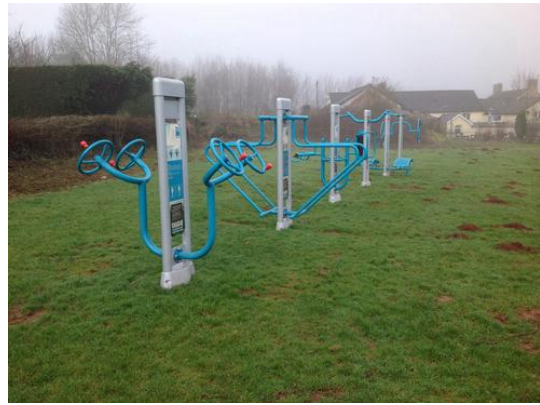
The recreation ground consists of a play area fenced by steel bow top fencing with self closing gates

A MUGA kick about area and a youth shelter

Both areas are accessed by Tarmac pathways

Benches and picnic tables are located within the play area and also outside the play area boundary

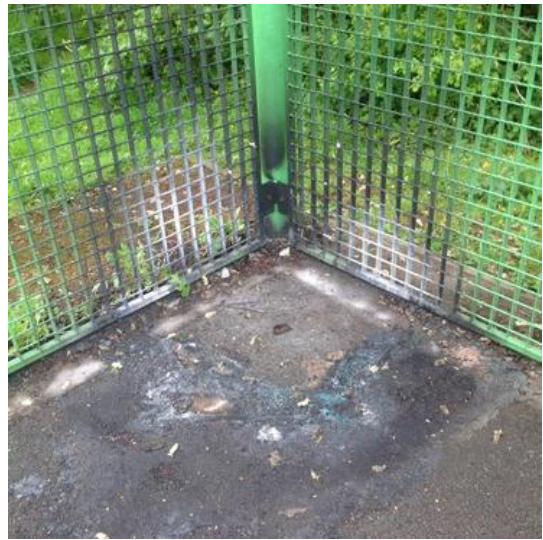
One of the basket swing suspension ropes has been wrapped, monitor

A small fire has caused minor damage to the ball court surface, an additional fire in the opposite corner has caused minor damage to the ball court surface and paintwork on the steel grid

There is some wear on the toddler swing chains, monitor and plan for replacement in the future

There is a rubber cover missing from one of the sit up benches

At the time of inspection the access gate was not self closing

The stopper spring on the cable ride has once again started to break, would suggest using a heavier duty spring next time it is changed.

monitor items noted

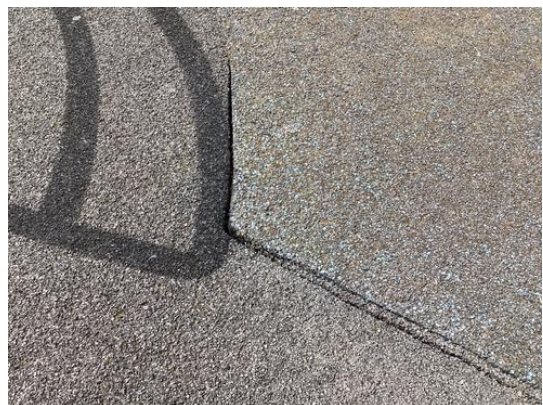
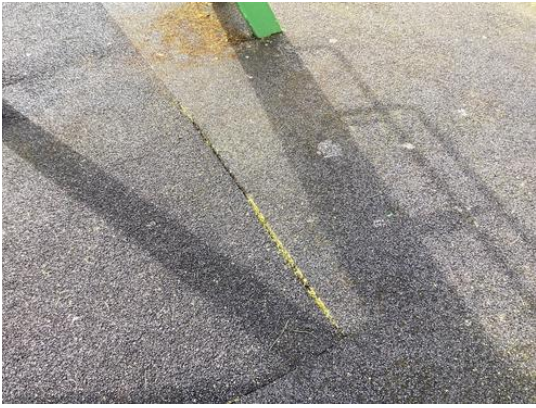
At the time of inspection all surfaces were found to be in a safe and useable condition although there are some areas of joint separation which should be monitored

The basket swing area has some self seeded grass growth that could be treated if possible while it is still manageable
