Play Area / Equipment Operational Inspection

LLANHARRY COMMUNITY COUNCIL

Llanharry Recreation Ground

04.07.2023 09:18 BST

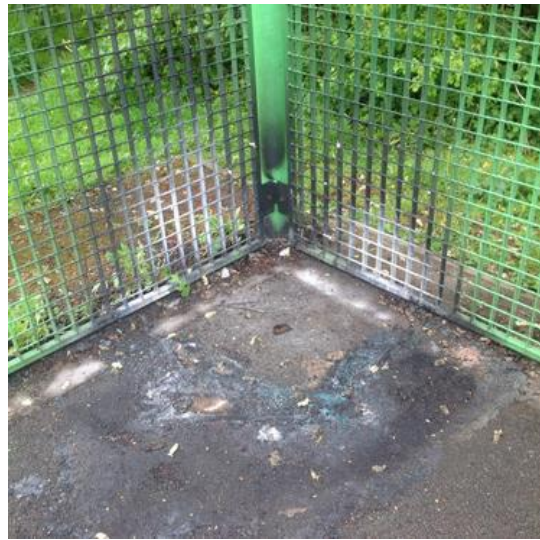
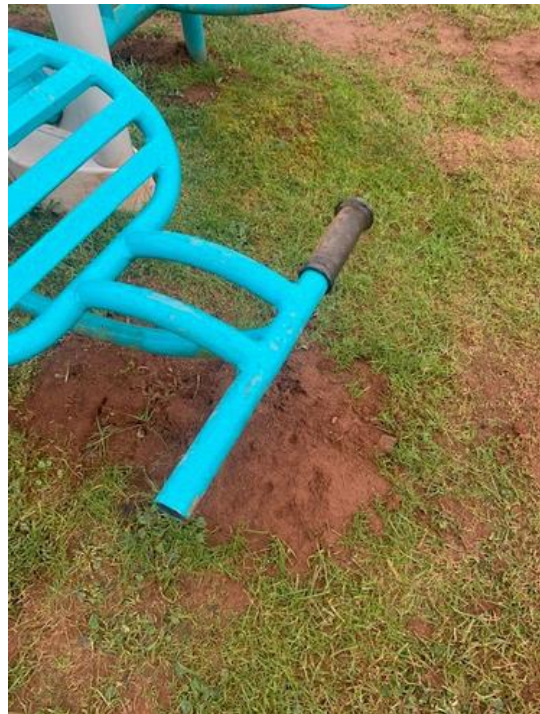
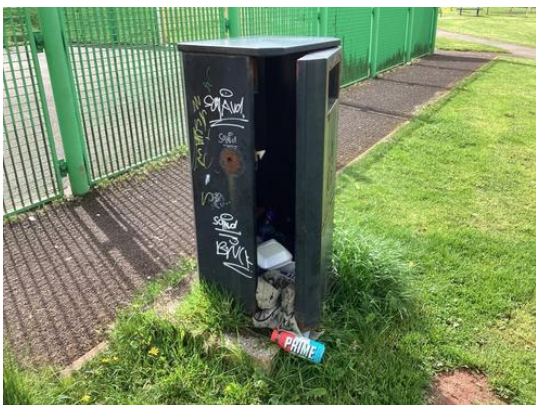
One of the basket swing suspension ropes has been wrapped, monitor

A small fire has caused minor damage to the ball court surface, an additional fire in the opposite corner has caused minor damage to the ball court surface and paintwork on the steel grid

There is some wear on the toddler swing chains, monitor and plan for replacement in the future

There is a rubber cover missing from one of the sit up benches

At the time of inspection the access gate was not self closing

The stopper spring on the cable ride has once again started to break, would suggest using a heavier duty spring next time it is changed.

monitor items noted

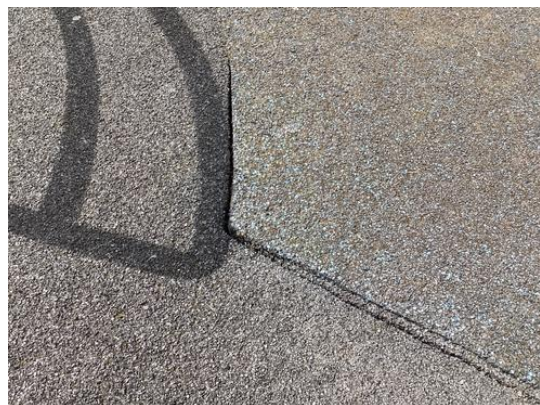
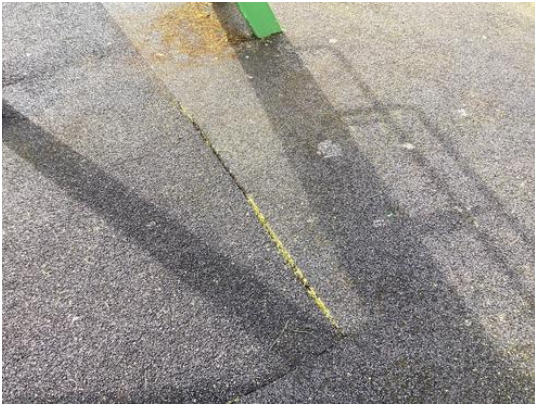
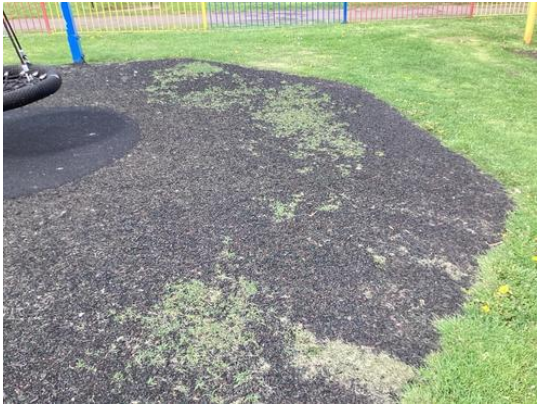
At the time of inspection all surfaces were found to be in a safe and useable condition although there are some areas of joint separation which should be monitored

The basket swing area has some self seeded grass growth that could be treated if possible while it is still manageable
