# Play Area / Equipment Operational Inspection

LLANHARRY COMMUNITY COUNCIL Comple					
Score	8 / 8 (100%)	Flagged items	0	Actions	0
Document No.					000078
Audit Title				LLANHARF	RY COMMUNITY COUNCIL
Client / Site				Llanharry Rec	reation Ground
Conducted on				31.08.	2023 09:20 BST
Prepared by					Jerry Widdas
Location					Llanharry
Personnel					
Jerry Widdas

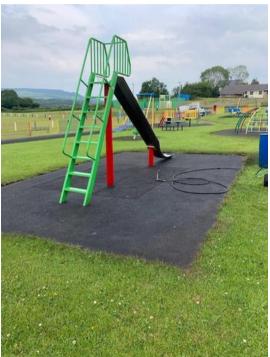
Photo 24

At the time of inspection all the equipment was found to be in a safe and useable condition
