Play Area / Equipment Operational Inspection

Llanharry Recreation Ground

LLANHARRY COMMUNITY COUNCIL

30/04/2019, 12:15

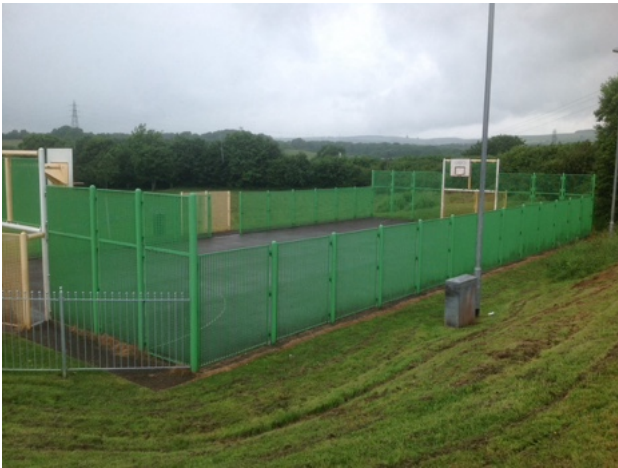
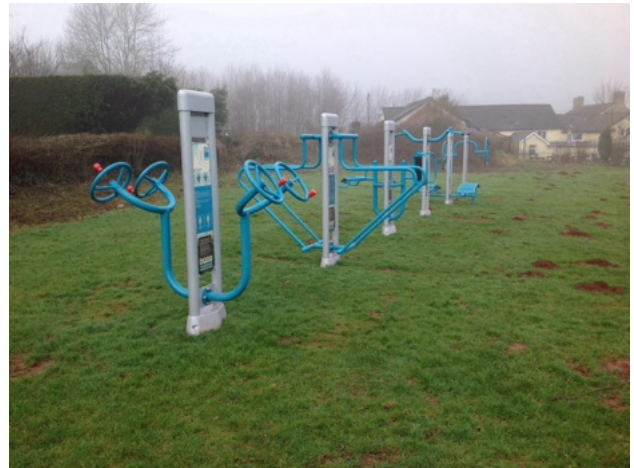
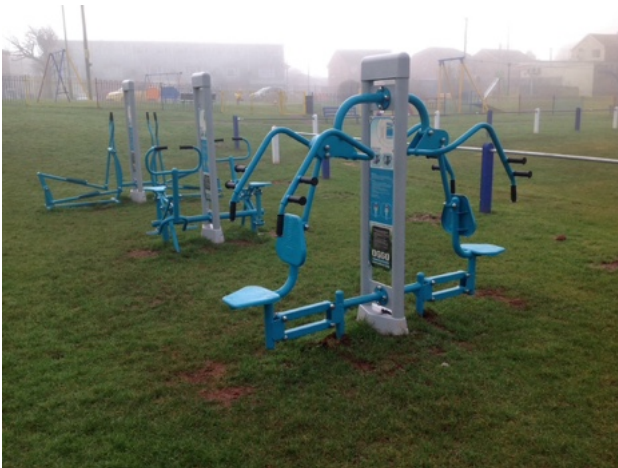
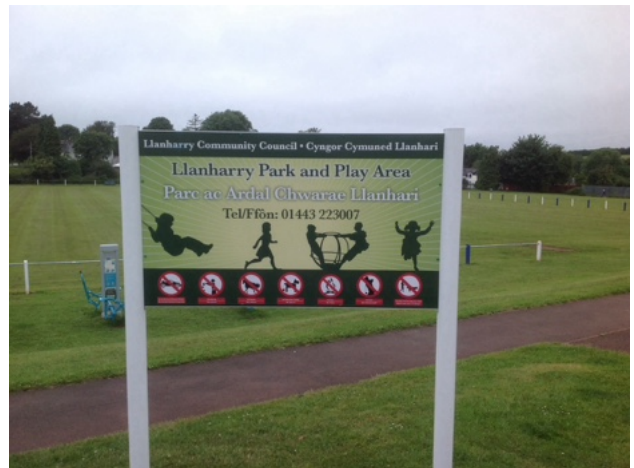
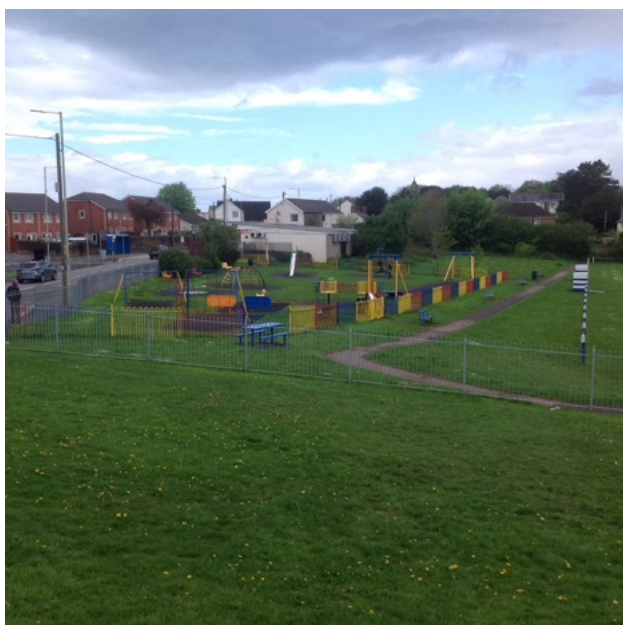
Question	Response	Details
GENERAL SITE DESCRIPTION		Score (1/1) 100%
Detail:	Yes	<p>The recreation ground consists of a play area fenced by steel bow top fencing with self closing gates</p> <p>A MUGA kick about area and a youth shelter</p> <p>Both areas are accessed by Tarmac pathways</p> <p>Benches and picnic tables are located within the play area and also outside the play area boundary</p>
<div style="display: flex; justify-content: space-around; align-items: flex-end;"> <div style="text-align: center;">

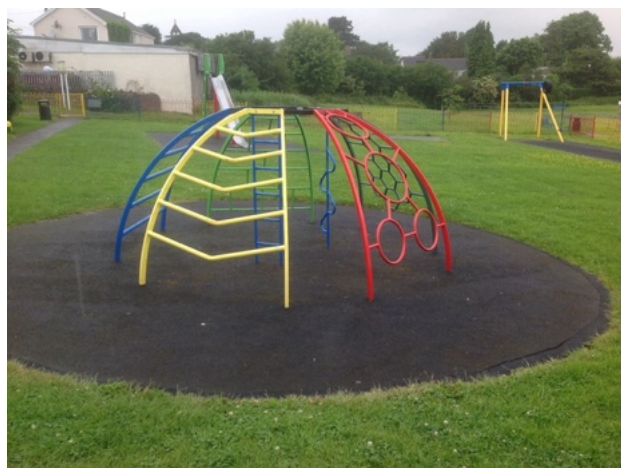
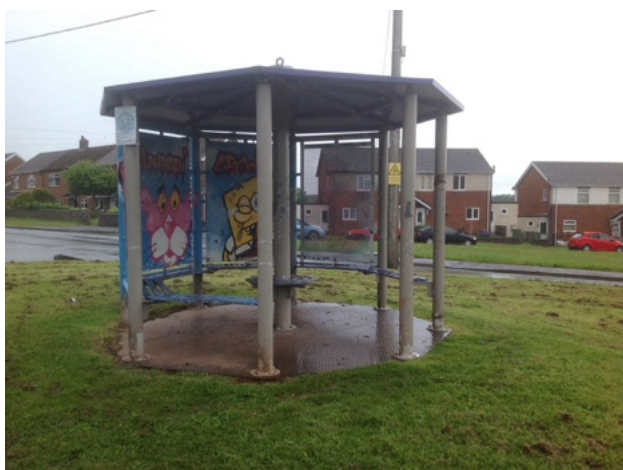
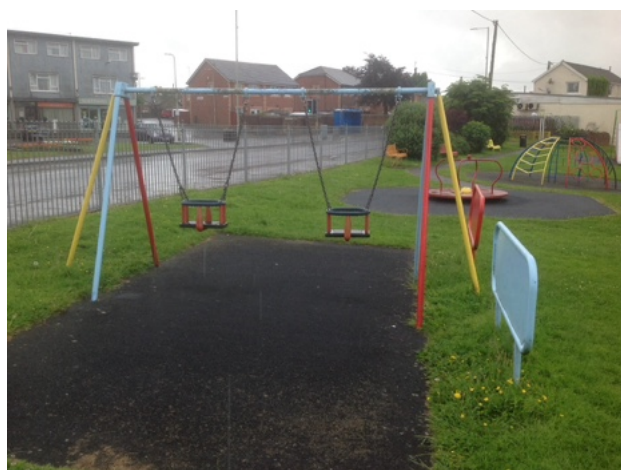
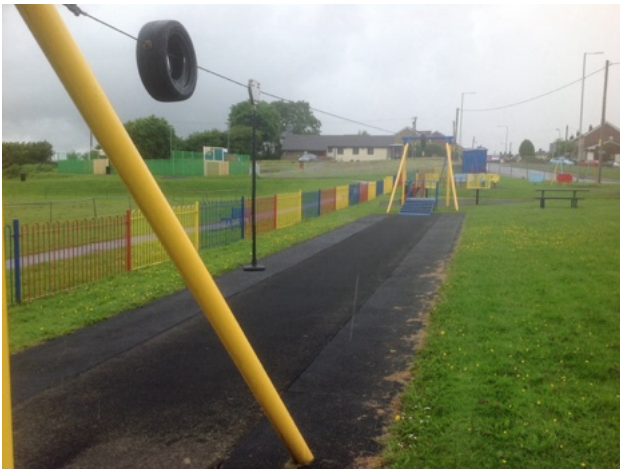
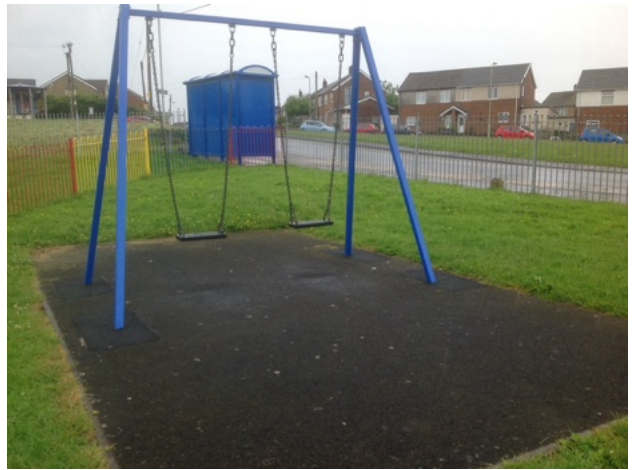
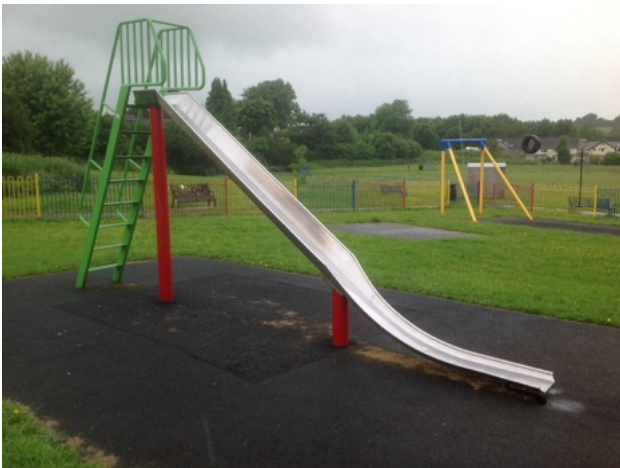
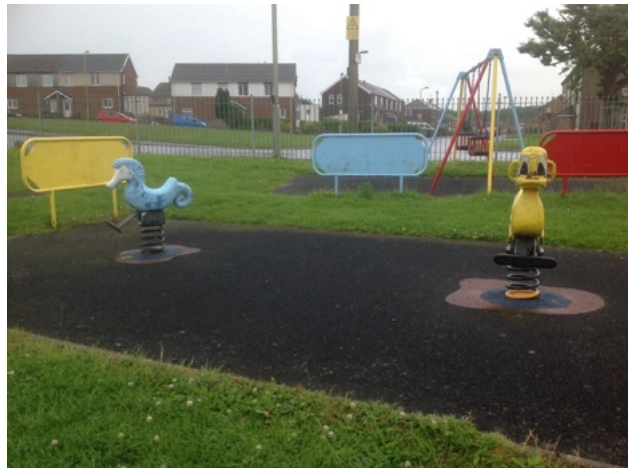
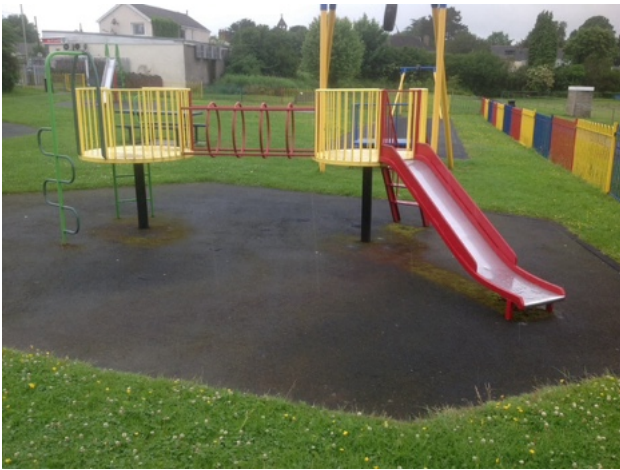
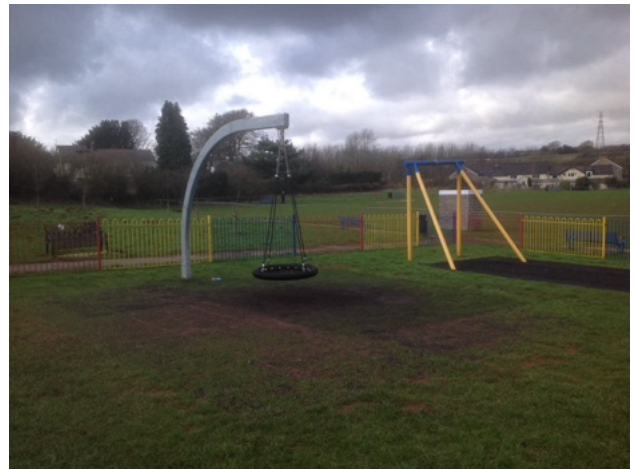
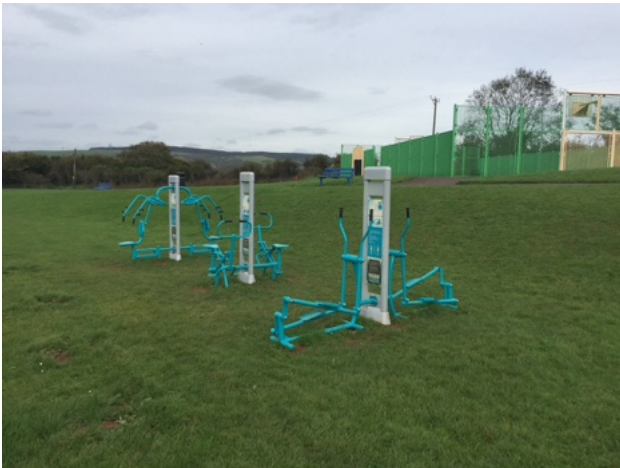
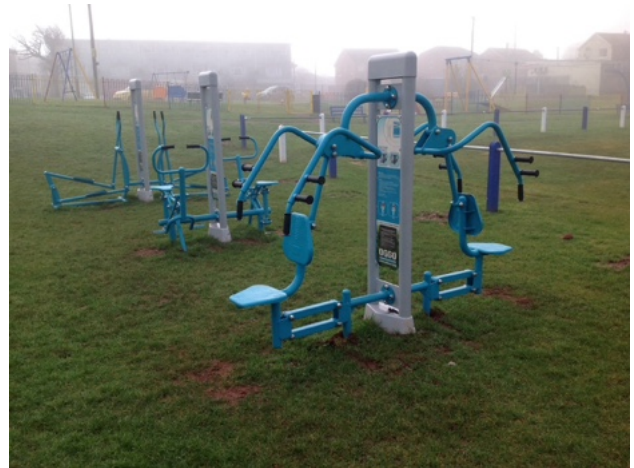
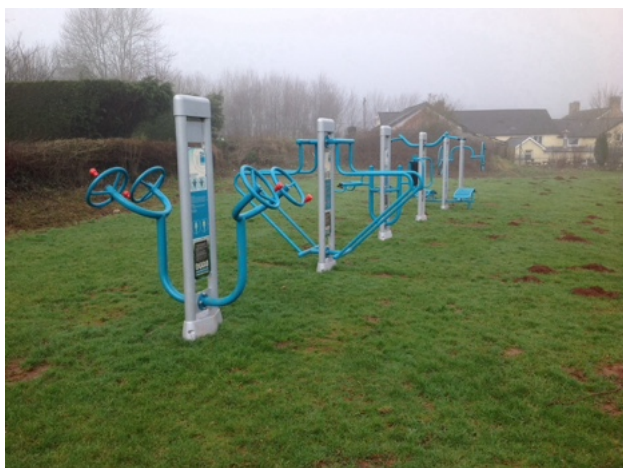
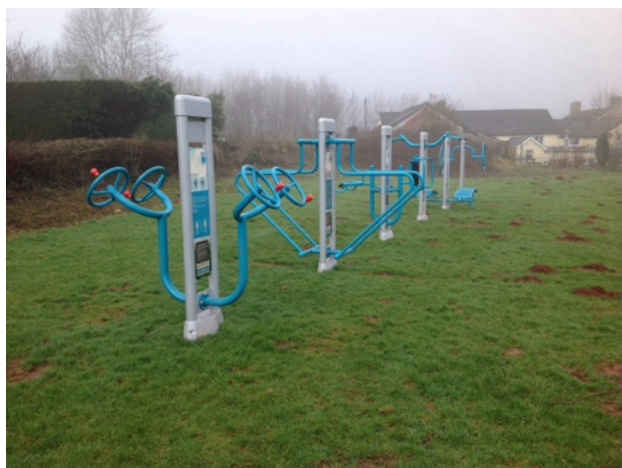
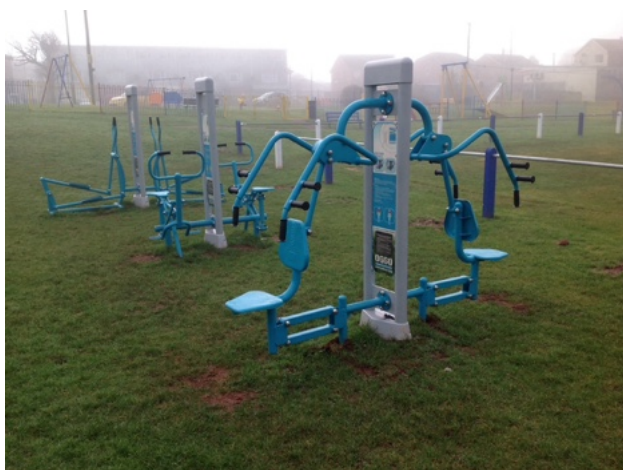
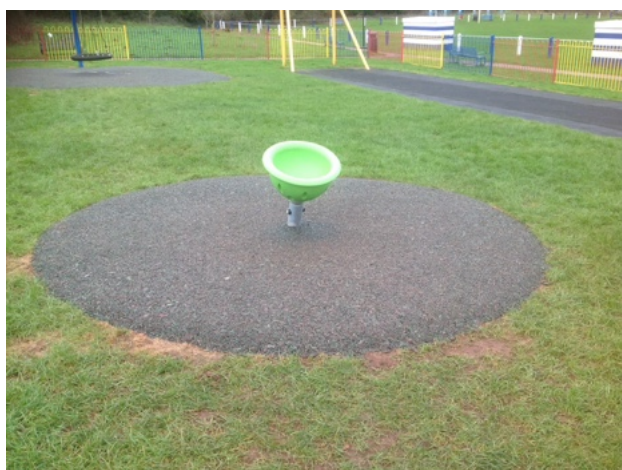
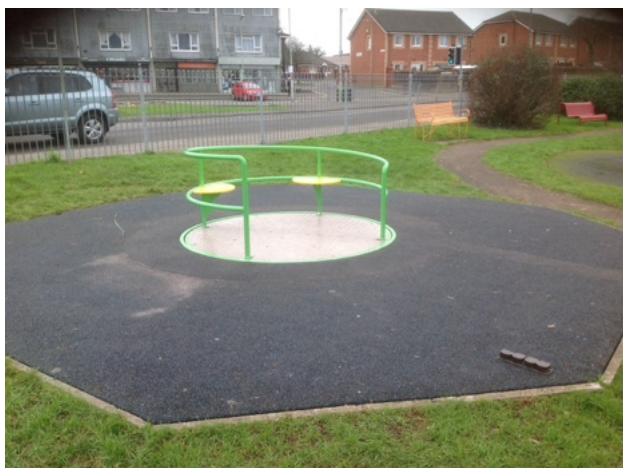
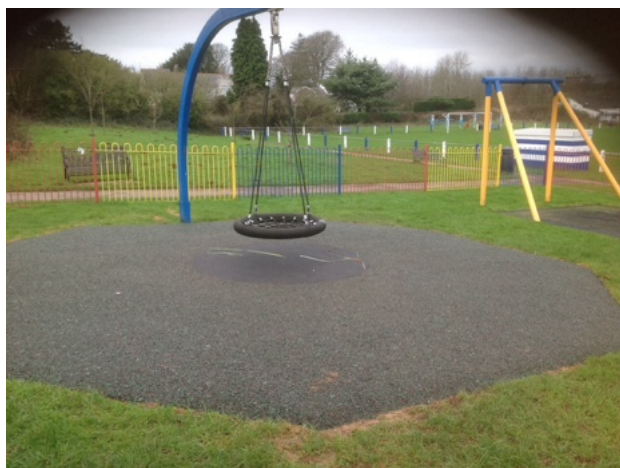
Question	Response	Details
Manufacturer identification and date of installation	Yes	<p>MUGA area supplied by PPL date unknown</p> <p>1 X 2 seat swing supplied and installed by Urban Recreation in 2016</p> <p>1 X Traditional cradle seat swing Wicksteed Leisure</p> <p>1 X Traditional Igloo climber Wicksteed Leisure</p> <p>1 X Wheelchair roundabout supplied and installed Urban Recreation Dec 2018</p> <p>1 X Multiplayer Unit Record Play</p> <p>1 X Steel cable ride Record Play</p> <p>1 X Freestanding slide Record Play</p> <p>2 X Spring animals Playworld Systems</p> <p>1 X Teen Shelter David Ogilvie Engineering</p> <p>1 X Cantilever Swing supplied Urban Recreation 2016</p> <p>9 X Fitness Items supplied Urban Recreation October 2017</p> <p>1 X Spinning Cup supplied and installed Urban Recreation Dec 2018</p>
<div>

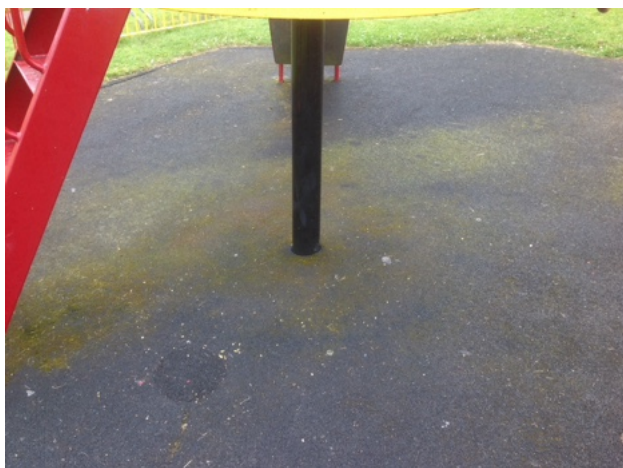
Appendix 23

Question	Response	Details
Safety Surfacing	Safe	<p>All items of play equipment are located on wet pour rubber safety surfacing</p> <p>Moss starting to collect on safety surface, monitor</p> <p>The surfacing is shrinking back from the perimeter edging, currently there are no trip points but monitor for any further deterioration</p>
<div style="display: flex; justify-content: space-around; align-items: flex-end;"> <div style="text-align: center;">

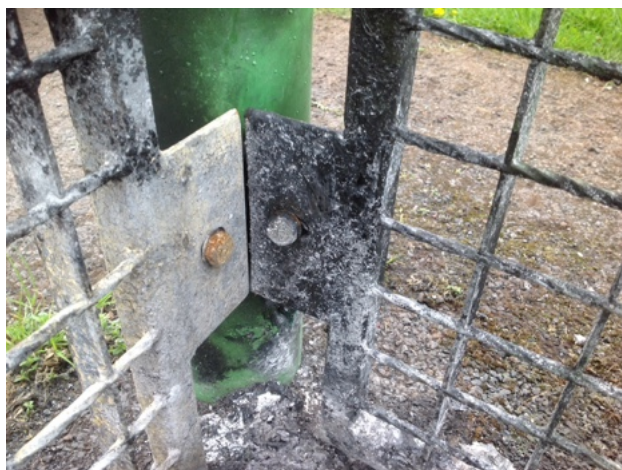
Appendix 26

Appendix 25 </div> </div>		
Equipment Findings	Safe	<p>A small fire has caused minor damage to the ball court surface, an additional fire in the opposite corner has caused minor damage to the ball court surface and paintwork on the steel grid</p>
<div style="display: flex; justify-content: space-around; align-items: flex-end;"> <div style="text-align: center;">
