Play Area / Equipment Operational Inspection

LLANHARRY COMMUNITY COUNCIL

Document No.	000078
Audit Title	LLANHARRY COMMUNITY COUNCIL
Client / Site	Llanharry Recreation Ground
Conducted on	31st Mar, 2021 10:00 AM BST
Prepared by	Jerry Widdas
Location	Llanharry

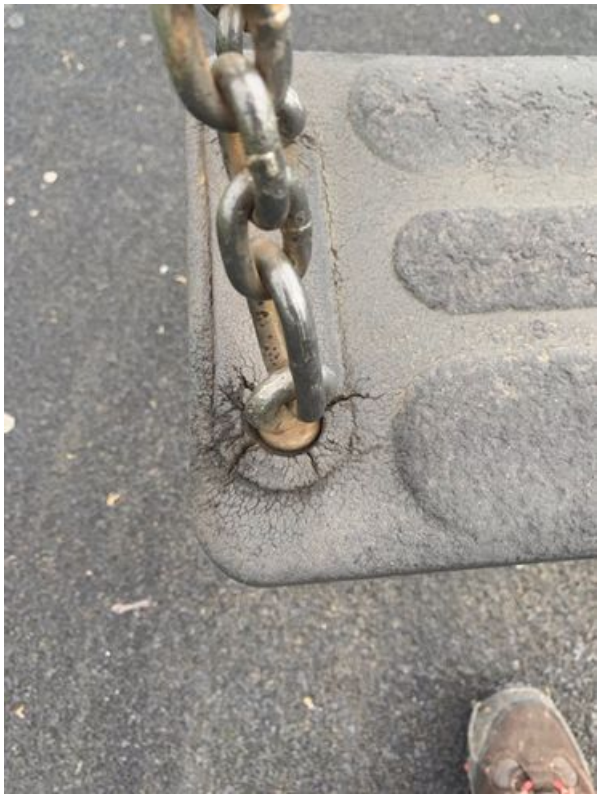
Photo 33

One corner of the roundabout edging has subsided exposing the concrete foundation and causing one concrete edge to sink slightly
The metal stairway on the multiplay unit is starting to corrode and get thin in places, this could have a steel plate welded in to prolong its life
All swing pivots were greased
The flat seats on the swing are starting to show the steel insert, monitor for further deterioration and replace
One of the basket swing suspension ropes has been wrapped, monitor
A small fire has caused minor damage to the ball court surface, an additional fire in the opposite corner has caused minor damage to the ball court surface and paintwork on the steel grid
The Spring stopper at the end of the cable ride has broken, this is not currently a safety issue but may deteriorate further with time, monitor and plan to replace at convenient time in the future.
There is some wear on the toddler swing chains, monitor and plan for replacement in the future

There is a rubber cover missing from one of the sit up benches
The three round litter bins surrounding the football field have advanced corrosion

monitor items noted
Gate at play area entrance is to be adjusted if possible for correct closing
