Play Area / Equipment Operational Inspection

LLANHARRY COMMUNITY COUNCIL

Document No.	000078
Audit Title	LLANHARRY COMMUNITY COUNCIL
Client / Site	Llanharry Recreation Ground
Conducted on	7 Sep 2021 13:00 BST
Prepared by	Jerry Widdas
Location	Llanharry

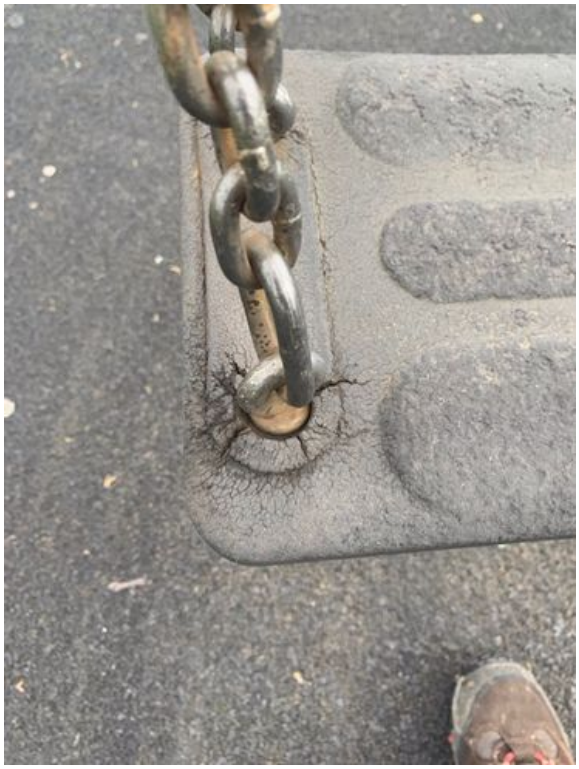
Photo 37

One corner of the roundabout edging has subsided exposing the concrete foundation and causing one concrete edge to sink slightly
The metal stairway on the multiplay unit is starting to corrode and get thin in places, this could have a steel plate welded in to prolong its life
The flat seats on the swing are starting to show the steel insert, monitor for further deterioration and replace
One of the basket swing suspension ropes has been wrapped, monitor
A small fire has caused minor damage to the ball court surface, an additional fire in the opposite corner has caused minor damage to the ball court surface and paintwork on the steel grid
The Spring stopper at the end of the cable ride has broken, this is not currently a safety issue but may deteriorate further with time, monitor and plan to replace at convenient time in the future.
There is some wear on the toddler swing chains, monitor and plan for replacement in the future

There is a rubber cover missing from one of the sit up benches
The three round litter bins surrounding the football field have advanced corrosion
