# Play Area / Equipment Operational Inspection

# Llanharry Recreation Ground

LLANHARRY COMMUNITY COUNCIL

04/11/2019, 12:28

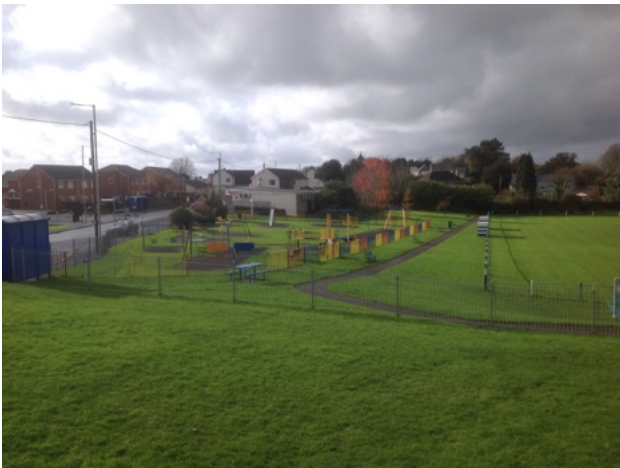
Question	Response	Details
<b>GENERAL SITE DESCRIPTION</b>		Score (1/1) 100%
Detail:	Yes	<p>The recreation ground consists of a play area fenced by steel bow top fencing with self closing gates</p> <p>A MUGA kick about area and a youth shelter</p> <p>Both areas are accessed by Tarmac pathways</p> <p>Benches and picnic tables are located within the play area and also outside the play area boundary</p>
<div style="display: flex; justify-content: space-around; align-items: flex-end;"> <div style="text-align: center;">   Appendix 1         </div> <div style="text-align: center;">   Appendix 2         </div> <div style="text-align: center;">   Appendix 3         </div> <div style="text-align: center;">   Appendix 4         </div> <div style="text-align: center;">   Appendix 5         </div> <div style="text-align: center;">   Appendix 6         </div> </div> <div style="margin-top: 20px; text-align: center;">   Appendix 7         </div>

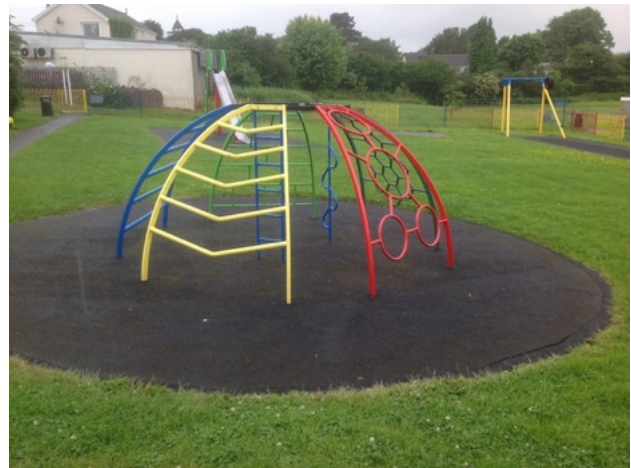
Appendix 8

Question	Response	Details
Manufacturer identification and date of installation	Yes	MUGA area supplied by PPL date unknown 1 X 2 seat swing supplied and installed by Urban Recreation in 2016 1 X Traditional cradle seat swing Wicksteed Leisure 1 X Traditional Igloo climber Wicksteed Leisure 1 X Wheelchair roundabout supplied and installed Urban Recreation Dec 2018 1 X Multiplayer Unit Record Play 1 X Steel cable ride Record Play 1 X Freestanding slide Record Play 2 X Spring animals Playworld Systems 1 X Teen Shelter David Ogilvie Engineering 1 X Cantilever Swing supplied Urban Recreation 2016 9 X Fitness Items supplied Urban Recreation October 2017 1 X Spinning Cup supplied and installed Urban Recreation Dec 2018
<div style="display: flex; flex-wrap: wrap; justify-content: space-around;"> <div style="text-align: center;">
