# Safety Inspection Report

Annual Inspection

## Ty Isaf Play Area

09 June 2022

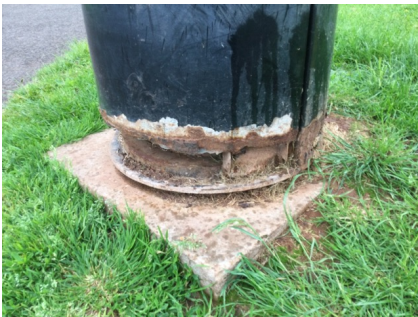
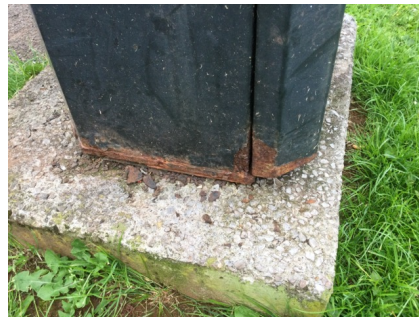
Item has corrosion.

Treat and repair.

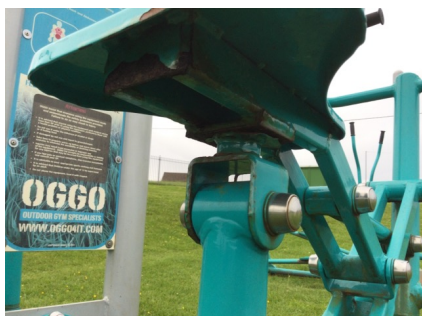
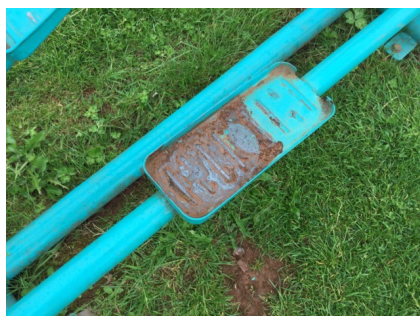
Item has corrosion.

Treat and repair.

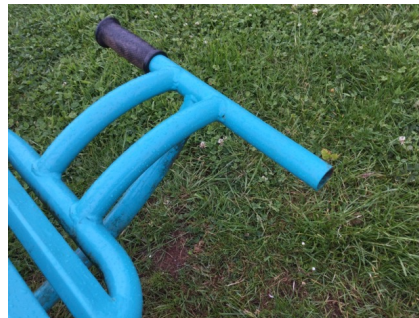
Hand grip is missing.

Replace missing grip.

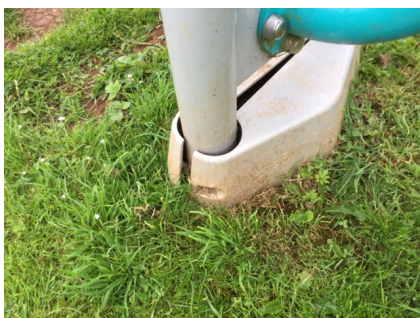
Bolt(s) loose.

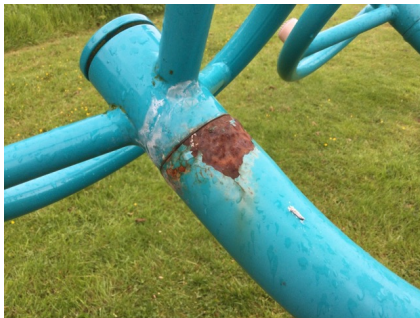
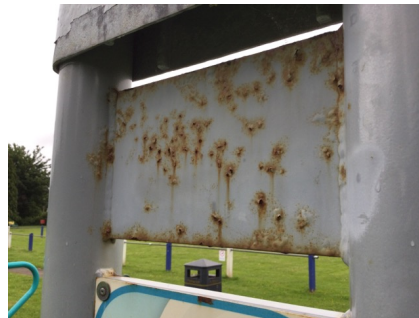
Item has corrosion.

Treat and repair.

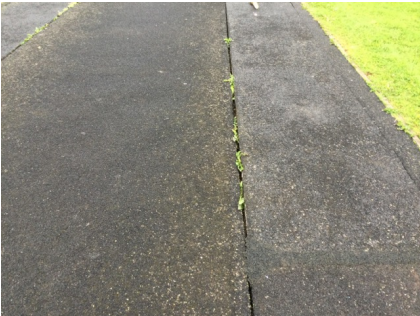
Shrinkage / separation of the surface. This may give a trip hazard.

Repair.

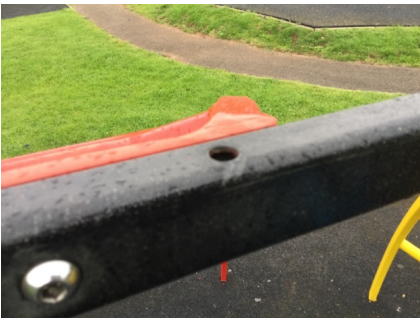
Cap missing.

Replace.

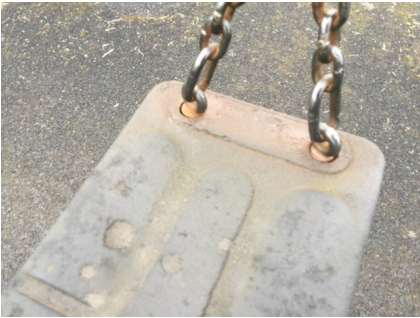
Loose swing seat eye-bolts.
